**Hazard Identification Assessment Report
Woodsreef Mine Major Rehabilitation Project
NSW Trade and Investment
Division of Resources & Energy**

Report Number 610.10893.00030

1 December 2014

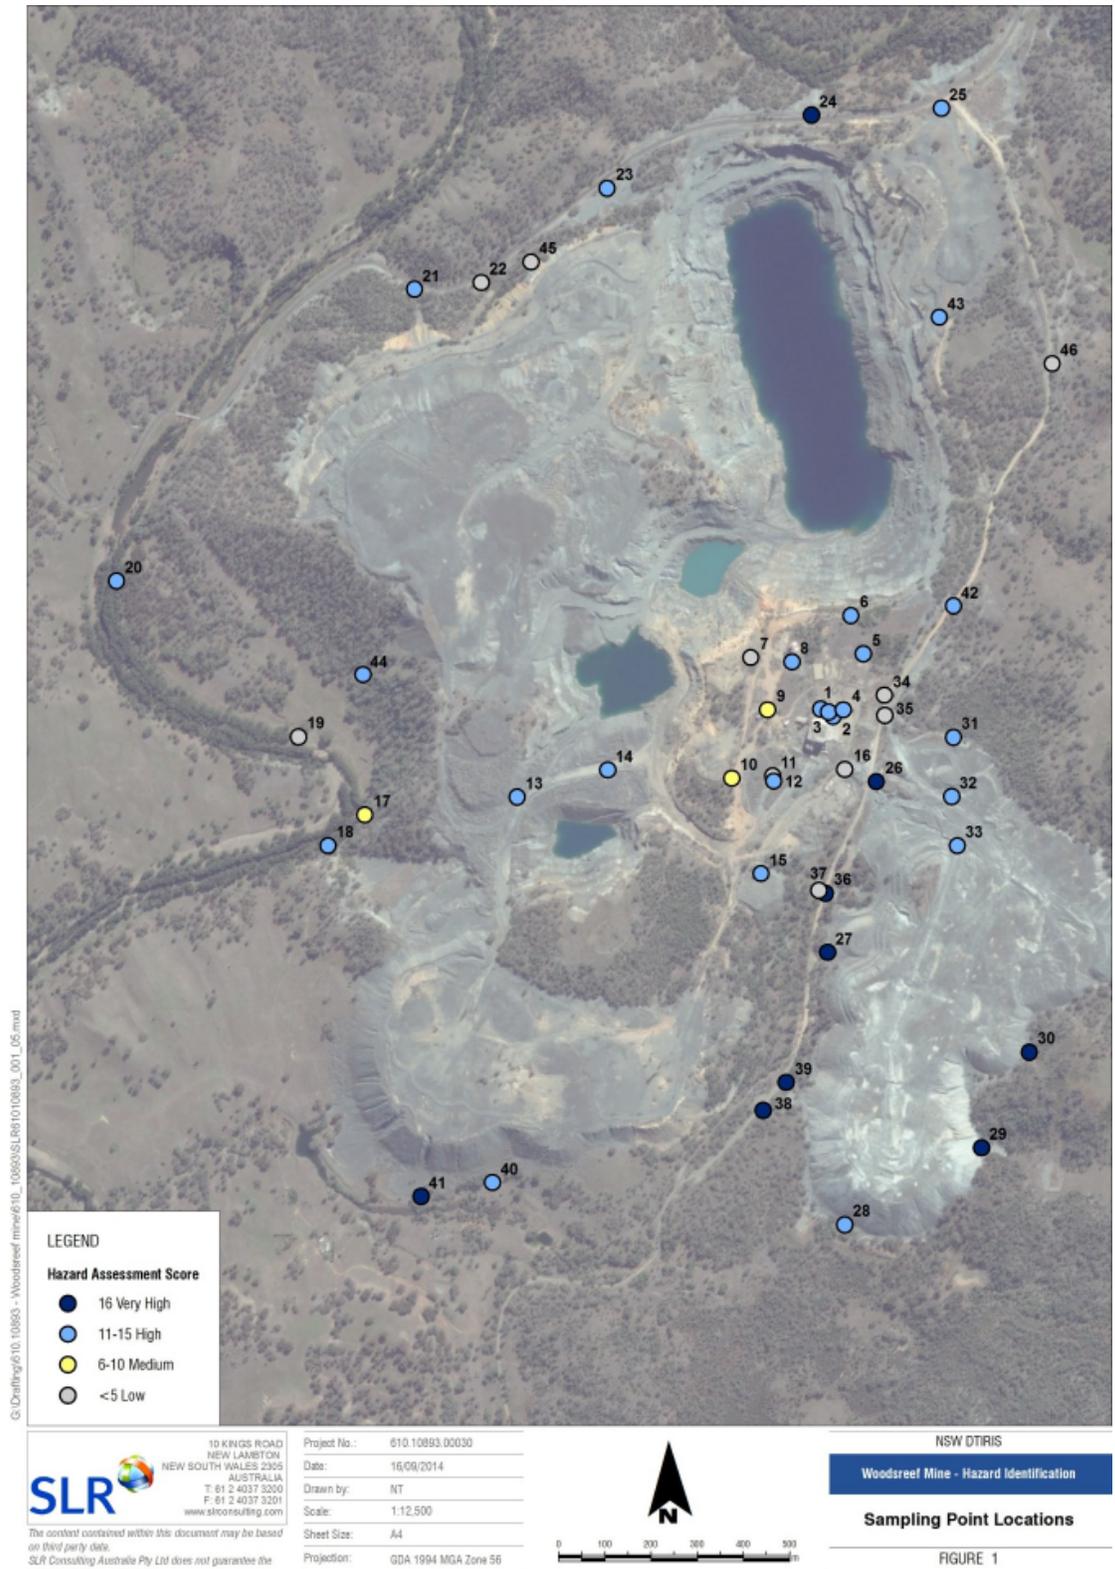
Figure 4 Hazard Assessment Scores for Individual Sampling Sites.

Area	Site Hazard Assessment (2 = low, 10 = high)	Lab Analysis Hazard Assessment (0 = low, 6= high)	Overall Asbestos Hazard Assessment Score (2= low, 16= very high)	Potential to release asbestos fibres through off-site migration of asbestos and exposure of the public to elevated levels of asbestos fibres
Ironbark Creek, adjacent to pumping station	3	2	5	Low
Ironbark Creek, adjacent to tyre mount, floodplain	8	6	14	High
Ironbark Creek, east flood plain, midway	8	0	8	Medium
Ironbark Creek, start of walking track NE	10	0	10	Medium
North of mine central waypoint, north side of Bundarra – Barraba Road	10	6	16	Very High
Entrance to mine, east of building	5	2	7	Medium
South end tailings, east road culvert, adjacent to private land	10	6	16	Medium
Flora Trail adjacent to pit 1, west	5	6	11	High
West of waste dump near pumping station	10	4	14	Very High
North west of overburden	5	4	9	Medium

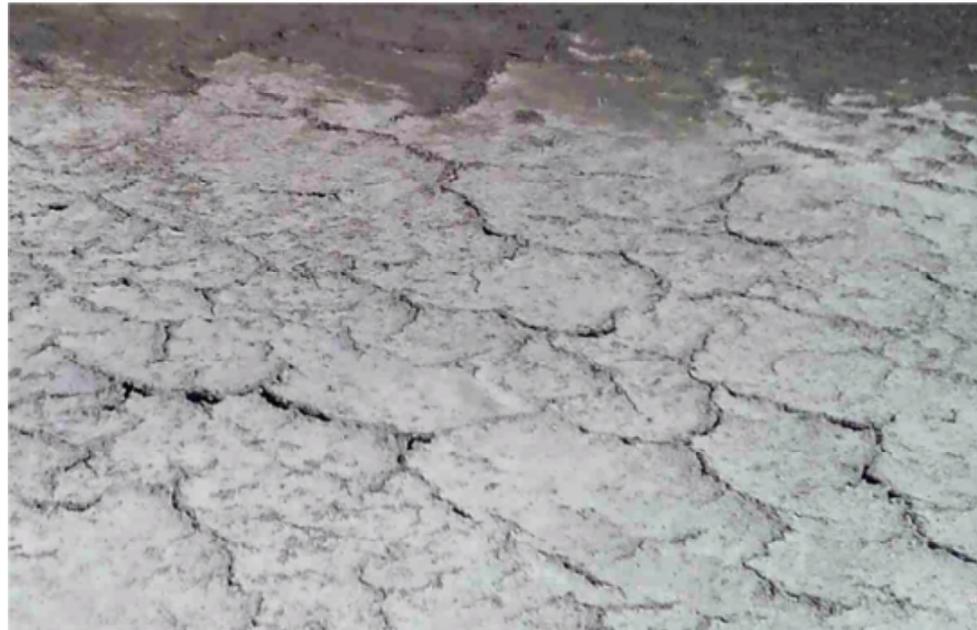
Mill Building Vicinity	Sample No 610.10893.00030/12
Site Observations	
Location	Stockpile south of building run-off
GPS	282596 (Northing), 6633876 (Easting)
Visual Findings	Rock soil matrix
Crusting (Soft, Medium, Hard)	Soft
Migration Path	Off site
Laboratory Analysis	
Whole Sample Description	light brown/grey material, some layers and crusts
Asbestos Presence Fraction < 2mm	Chrysotile
Asbestos Description Fraction < 2mm	Fibrous masses
% Asbestos (vol/vol approx.)	95%
Trace Asbestos	Present
Hazard Assessment	High

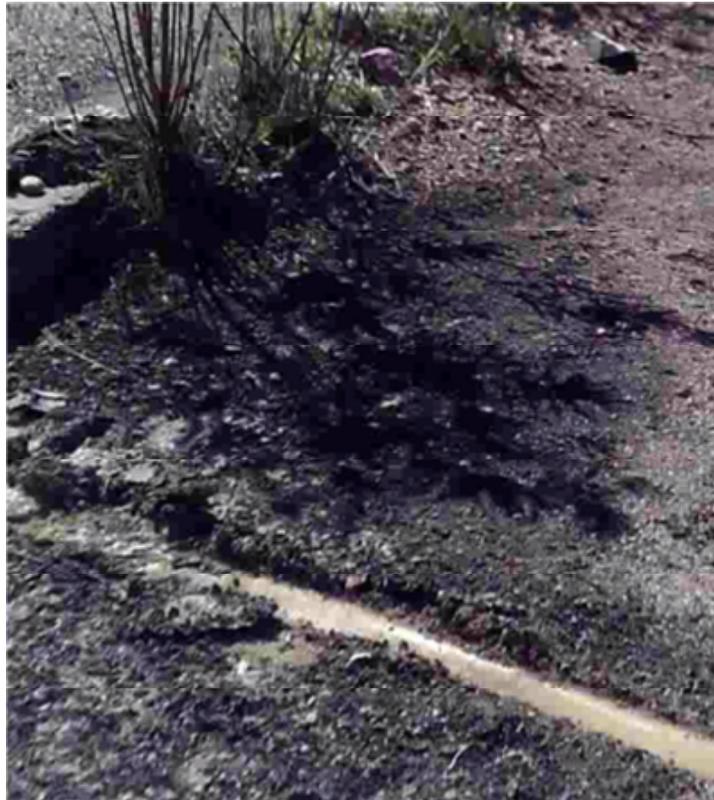
Proposed Containment Cell Vicinity		Sample No 610.10893.00030/4
Site Observations		
Location	On concrete slab, east of building	
GPS	282747 (Northing), 6634031 (Easting)	
Visual Findings	Detritus, Debris	
Crusting (Soft, Medium, Hard)	Soft	
Migration Path	Off site	
Laboratory Analysis		
Whole Sample Description	light brown/grey material, fibrous masses	
Asbestos Presence Fraction < 2mm	Chrysotile	
Asbestos Description Fraction < 2mm	Fibrous masses	
% Asbestos (vol/vol approx.)	25%	
Trace Asbestos	Present	
Hazard Assessment	High

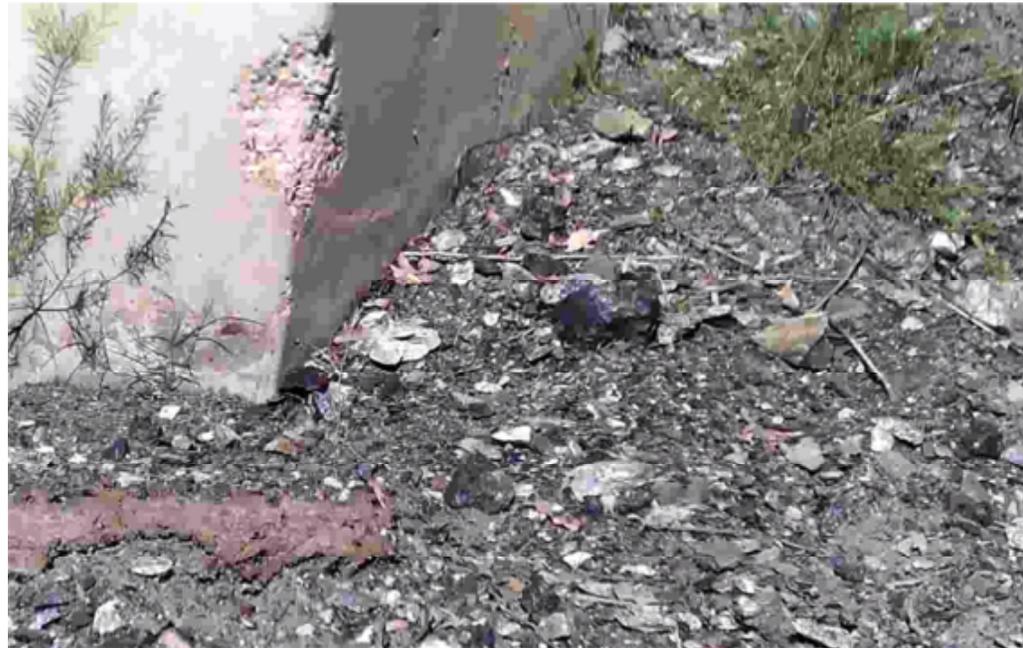
Additional Areas - Ironbark Creek, Adjacent to Pumping Station - Sample No 610.10893.00030/17	
Site Observations	
Location	Ironbark Creek, adjacent to pumping station
GPS	281711 (Northing), 6633803 (Easting)
Visual Findings	Fines
Crusting (Soft, Medium, Hard)	Hard, pebble rock
Migration Path	Off site
Laboratory Analysis	
Whole Sample Description	light grey soil, rocks and organic material
Asbestos Presence Fraction < 2mm	Chrysotile
Asbestos Description Fraction < 2mm	Bundles
% Asbestos (vol/vol approx.)	<0.1%
Trace Asbestos	Absent
Hazard Assessment	Low

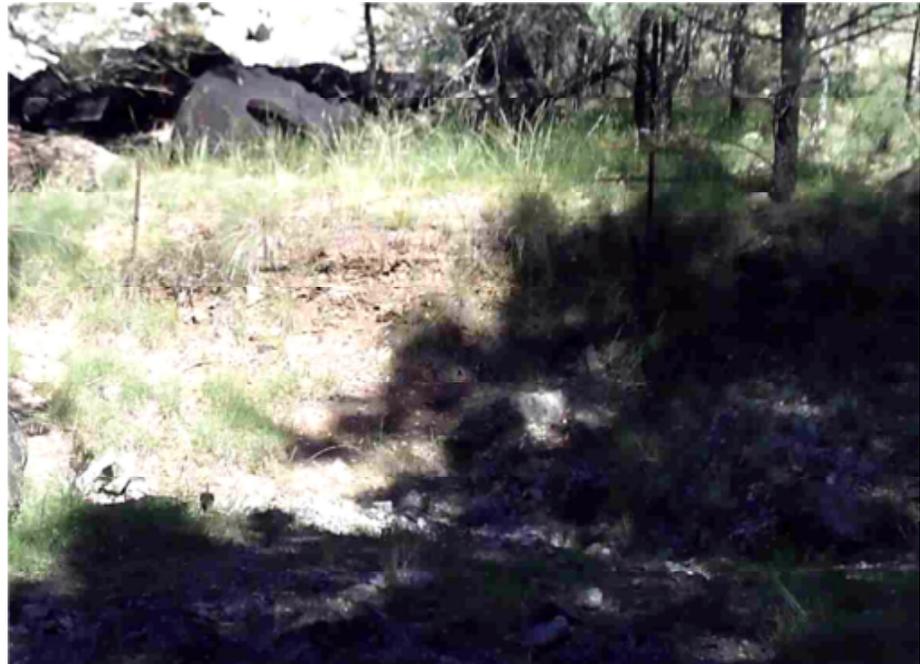
Additional Areas - Ironbark Creek, Adjacent to Tyre Mount, Floodplain - Sample No 610.10893.00030/18

Location	Ironbark Creek, adjacent to tyre mount, floodplain
GPS	281631 (Northing), 6633737 (Easting)
Visual Findings	Run-off of overburden soil
Crusting (Soft, Medium, Hard)	Medium
Migration Path	Off site

Whole Sample Description	light brown soil, rocks and organic material
Asbestos Presence Fraction < 2mm	Chrysotile
Asbestos Description Fraction < 2mm	Bundles
% Asbestos (vol/vol approx.)	80%
Trace Asbestos	Present

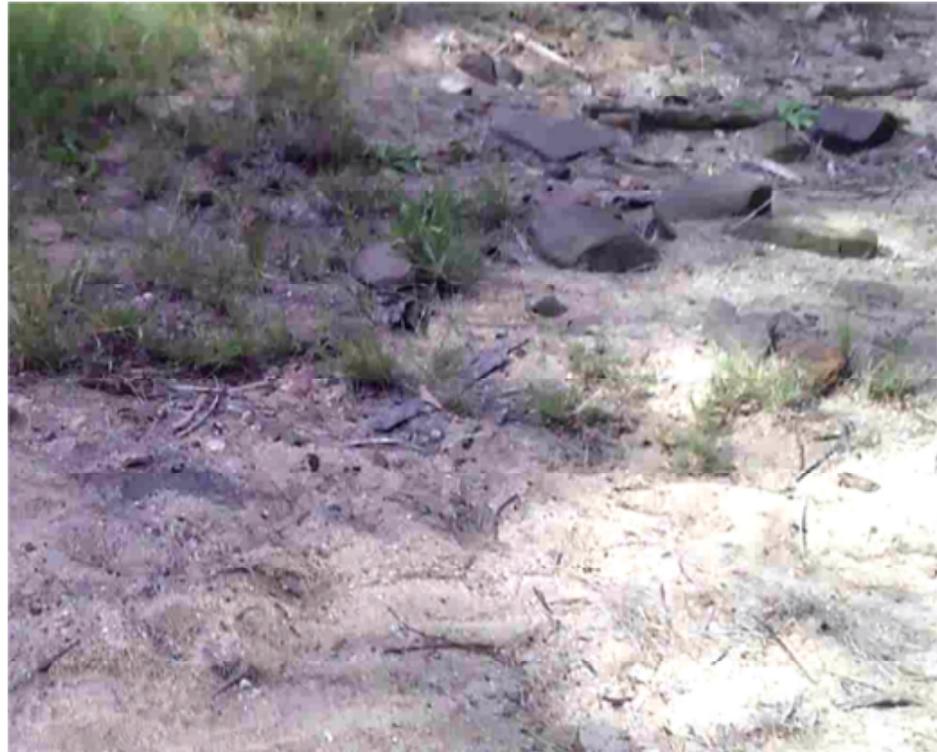
Location	Ironbark Creek, east flood plain, midway
GPS	281567 (Northing), 6633973 (Easting)
Visual Findings	Soil
Crusting (Soft, Medium, Hard)	Medium - some crusting
Migration Path	Off site

Whole Sample Description	Sandy soil, rocks organic material
Asbestos Presence Fraction < 2mm	Absent
Asbestos Description Fraction < 2mm	Absent
% Asbestos (vol/vol approx.)	0%
Trace Asbestos	Absent

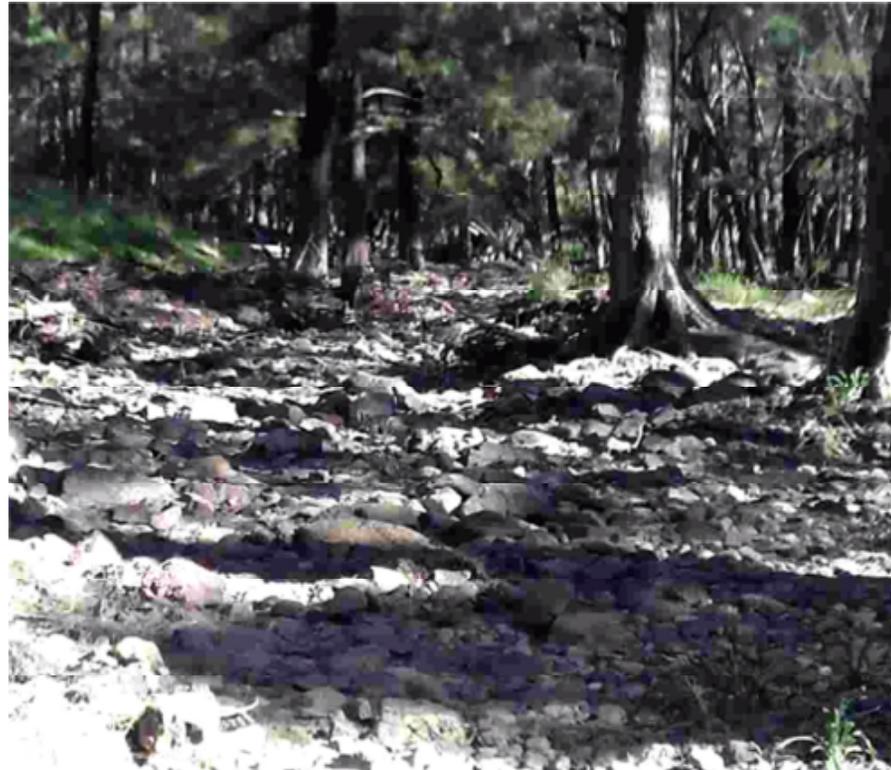
Additional Areas - Ironbark Creek, Start of Walking Track North East- Sample No 610.10893.00030/20	
Site Observations	
Location	Ironbark Creek, start of walking track NE
GPS	281173 (Northing), 6634310 (Easting)
Visual Findings	Riverbed sand/sediments
Crusting (Soft, Medium, Hard)	No crusting
Migration Path	Off site
Laboratory Analysis	
Whole Sample Description	Sand and rocks
Asbestos Presence Fraction < 2mm	Absent
Asbestos Description Fraction < 2mm	Absent
% Asbestos (vol/vol approx.)	0%
Trace Asbestos	Absent
Hazard Assessment	Medium

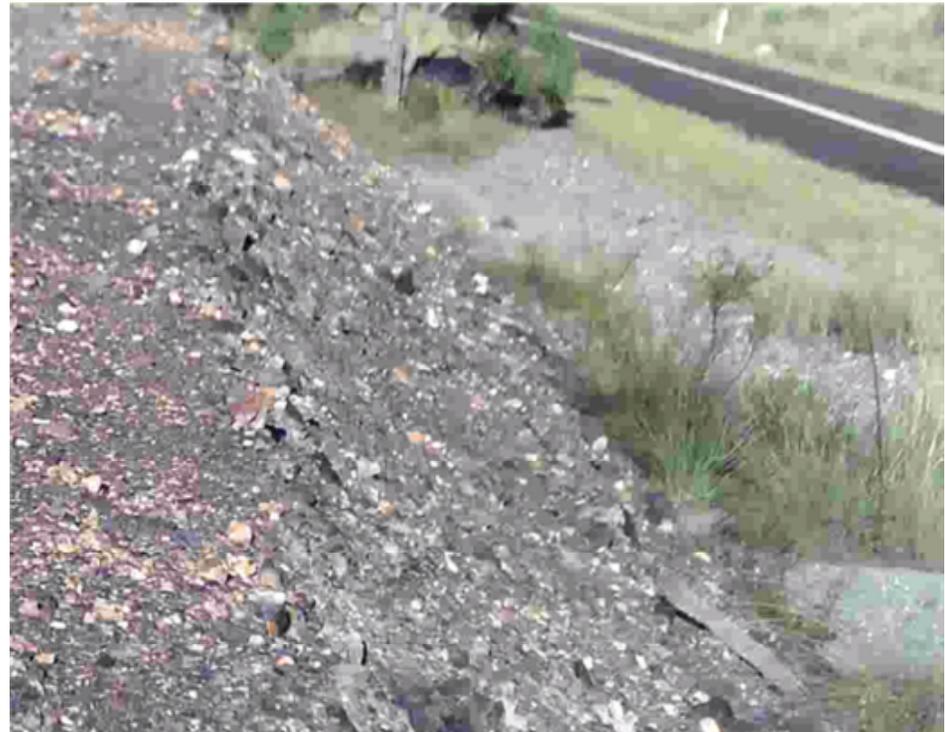
Additional Areas - North of Mine Central Waypoint, North Side of Bundarra – Barraba Road - Sample No 610.10893.00030/24

Location	North of mine central waypoint, north side of Bundarra – Barraba Road
GPS	282678 (Northing), 6635319 (Easting)
Visual Findings	Runoff soil
Crusting (Soft, Medium, Hard)	Soft
Migration Path	Off site

Whole Sample Description	grey brown soil and rocks
Asbestos Presence Fraction < 2mm	Chrysotile
Asbestos Description Fraction < 2mm	Bundles
% Asbestos (vol/vol approx.)	2%
Trace Asbestos	Present

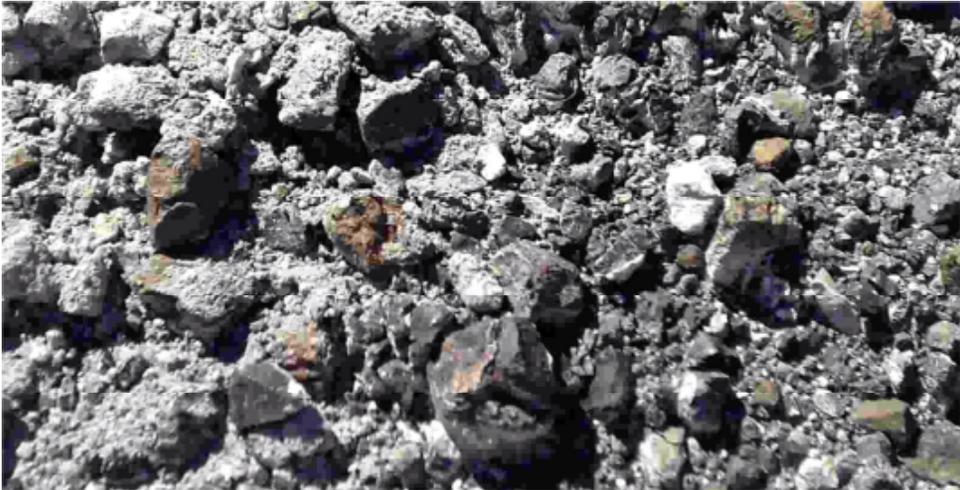
Additional Areas - Entrance to Mine, East of Building - Sample No 610.10893.00030/34	
Site Observations	
Location	Entrance to mine, east of building
GPS	282836 (Northing), 6634062 (Easting)
Visual Findings	Friable tailings
Crusting (Soft, Medium, Hard)	Soft
Migration Path	On site
Laboratory Analysis	
Whole Sample Description	grey brown soil and rocks
Asbestos Presence Fraction < 2mm	Chrysotile
Asbestos Description Fraction < 2mm	Bundles
% Asbestos (vol/vol approx.)	<0.1%
Trace Asbestos	Absent
Hazard Assessment	Medium

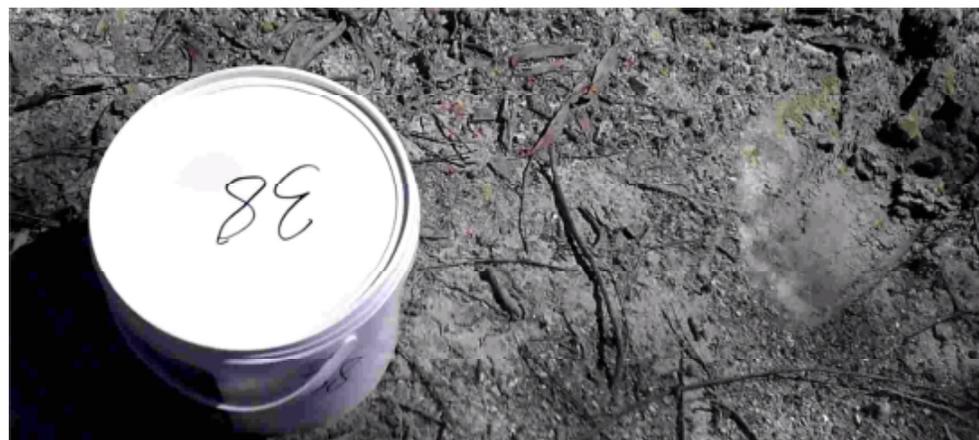
**Siltation systems sediments-South End Tailings, East Road Culvert, Adjacent to Private Land-
 Sample No 610.10893.00030/38**

Location	South end tailings, east road culvert, adjacent to private land
GPS	282573 (Northing), 6633164 (Easting)
Visual Findings	Tailings soil
Crusting (Soft, Medium, Hard)	Soft, visible fibres
Migration Path	Off site

Whole Sample Description	light brown soil and crusts
Asbestos Presence Fraction < 2mm	Chrysotile
Asbestos Description Fraction < 2mm	Fibrous masses
% Asbestos (vol/vol approx.)	5%
Trace Asbestos	Present

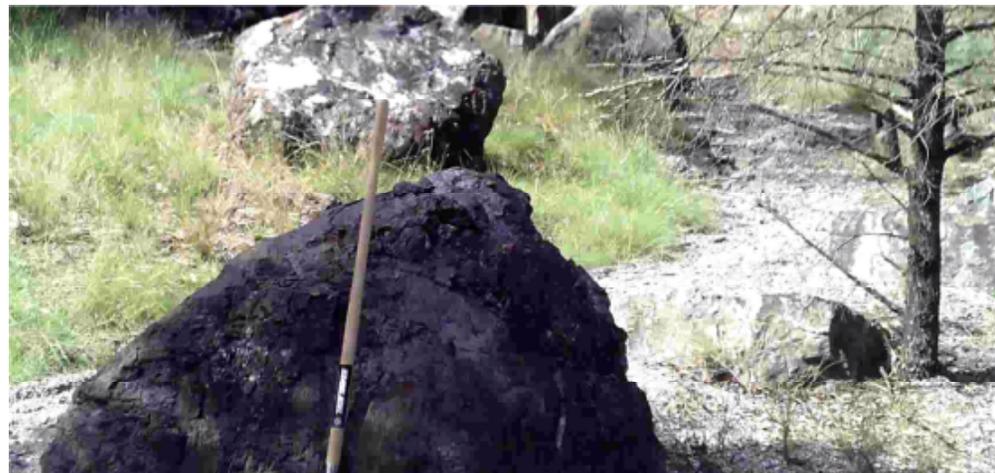
Location	West of waste dump near pumping station
GPS	281706 (Northing), 6634107 (Easting)
Visual Findings	Soil
Crusting (Soft, Medium, Hard)	Soft
Migration Path	Off site

Whole Sample Description	rocks, gravel and leaves
Asbestos Presence Fraction < 2mm	Chrysotile
Asbestos Description Fraction < 2mm	Natural asbestos (i.e unprocessed)
% Asbestos (vol/vol approx.)	<0.1%
Trace Asbestos	Present
