Dangerous Incident – Dump slump 7th November 2022

Dangerous incident | IncNo0043383

Open cut coal mine

Ground or strata failure

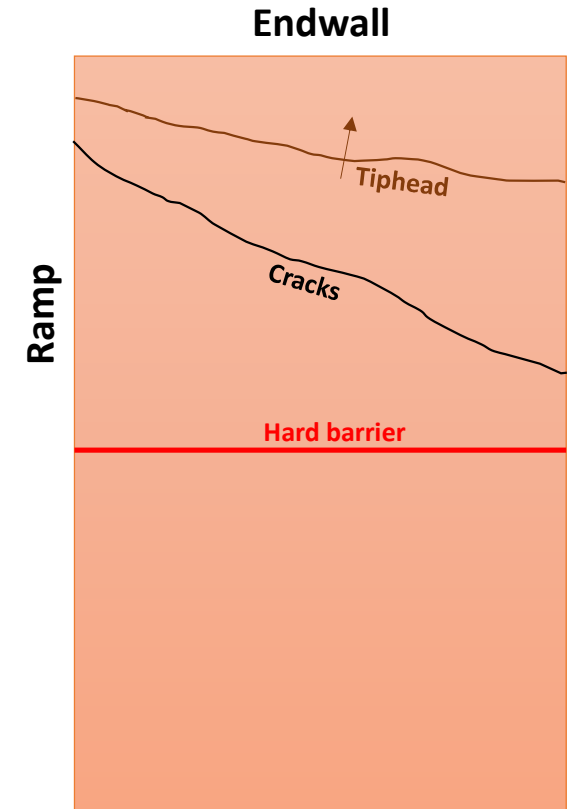
- **11:30pm:**
 - OCE receives call about cracking on the dump
 - OCE arrives and inspects dump
 - Cracks are diagonal and appear to be settling cracks
 - Remediation plan devised – hard barrier 100m back from dump, lighting plant relocated, dump to be cut down perpendicular to cracks.
- **03:20am:**
 - Dozer operator called to say he is stuck on the dump since it had given way
 - OCE initiated the emergency procedure

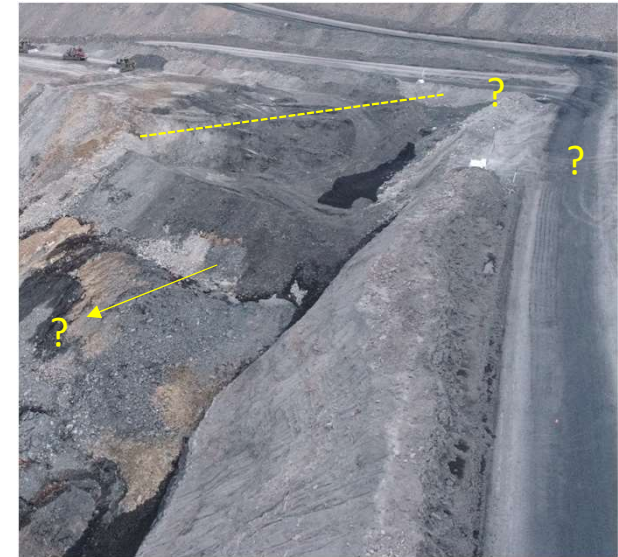
- **Prevent an escalation of this event**
 - Risk of further movement?
 - Risk to endwall?
 - Risk of propagation into adjacent ramp?
- **Prevent a reoccurrence elsewhere when operations restart**
 - Inspection of all other dumps
 - Preliminary geotechnical assessment
 - Detailed analysis of construction of all other dumps

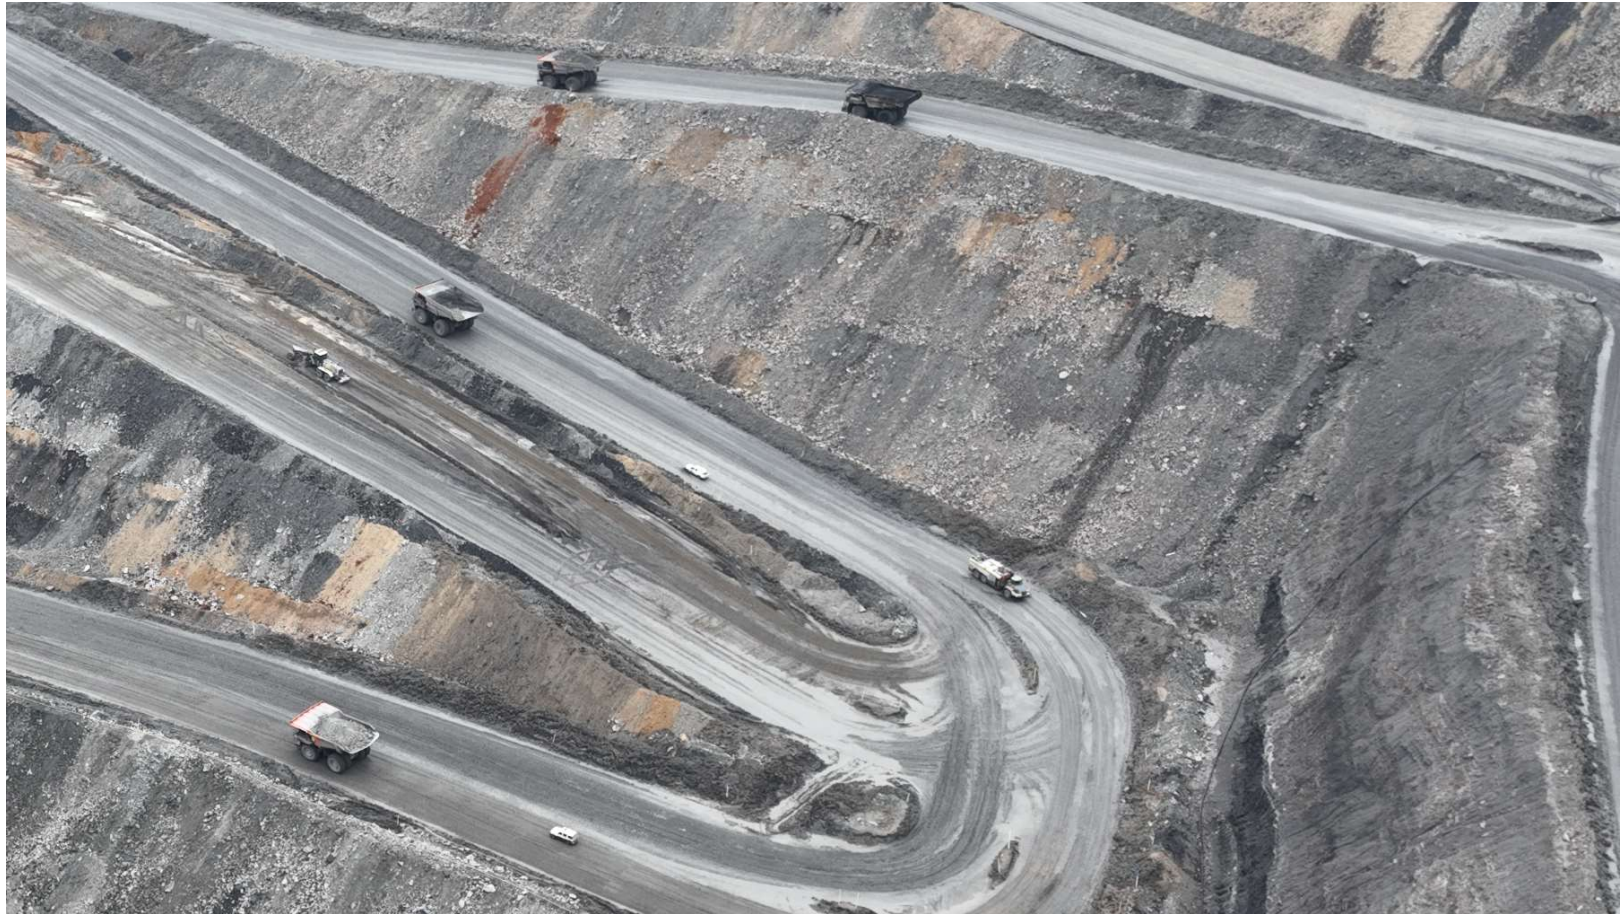
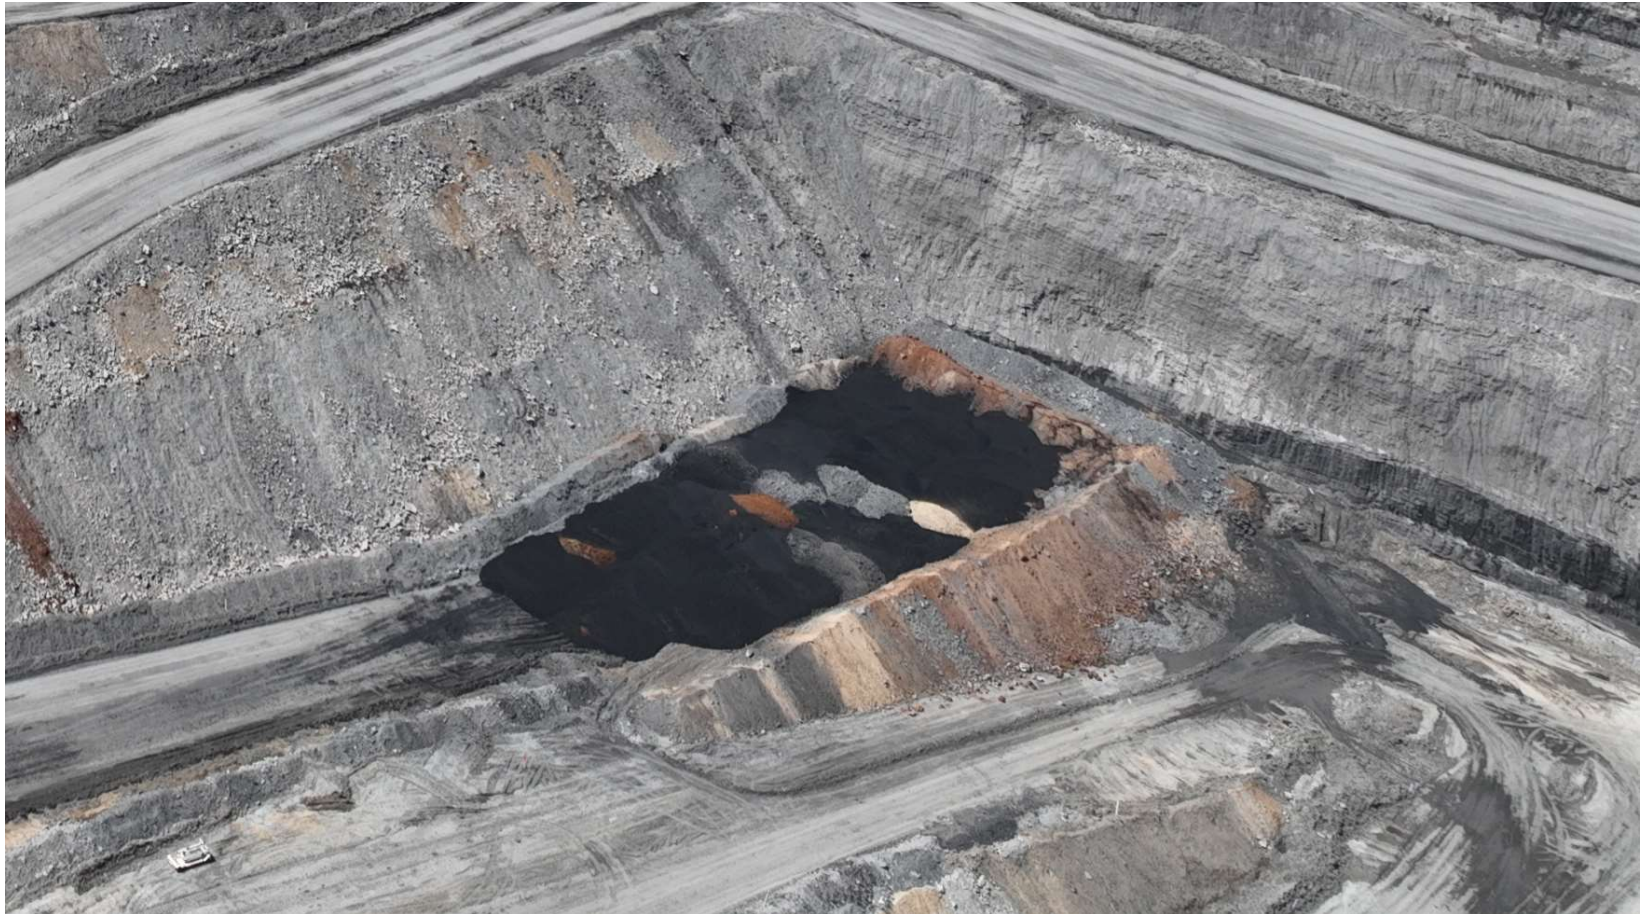
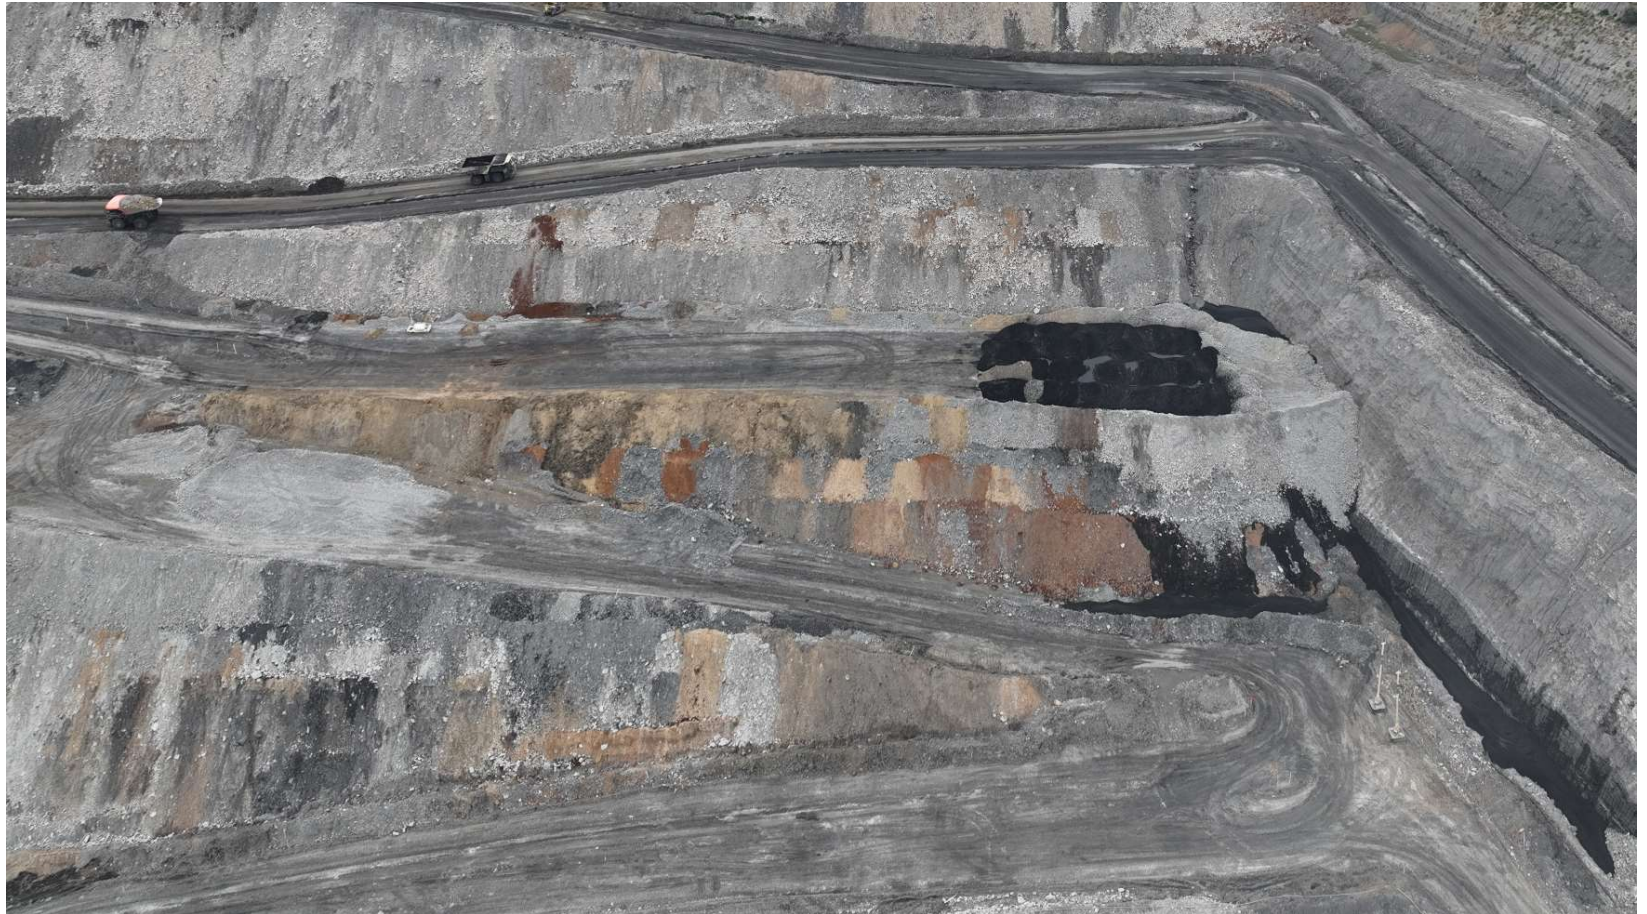
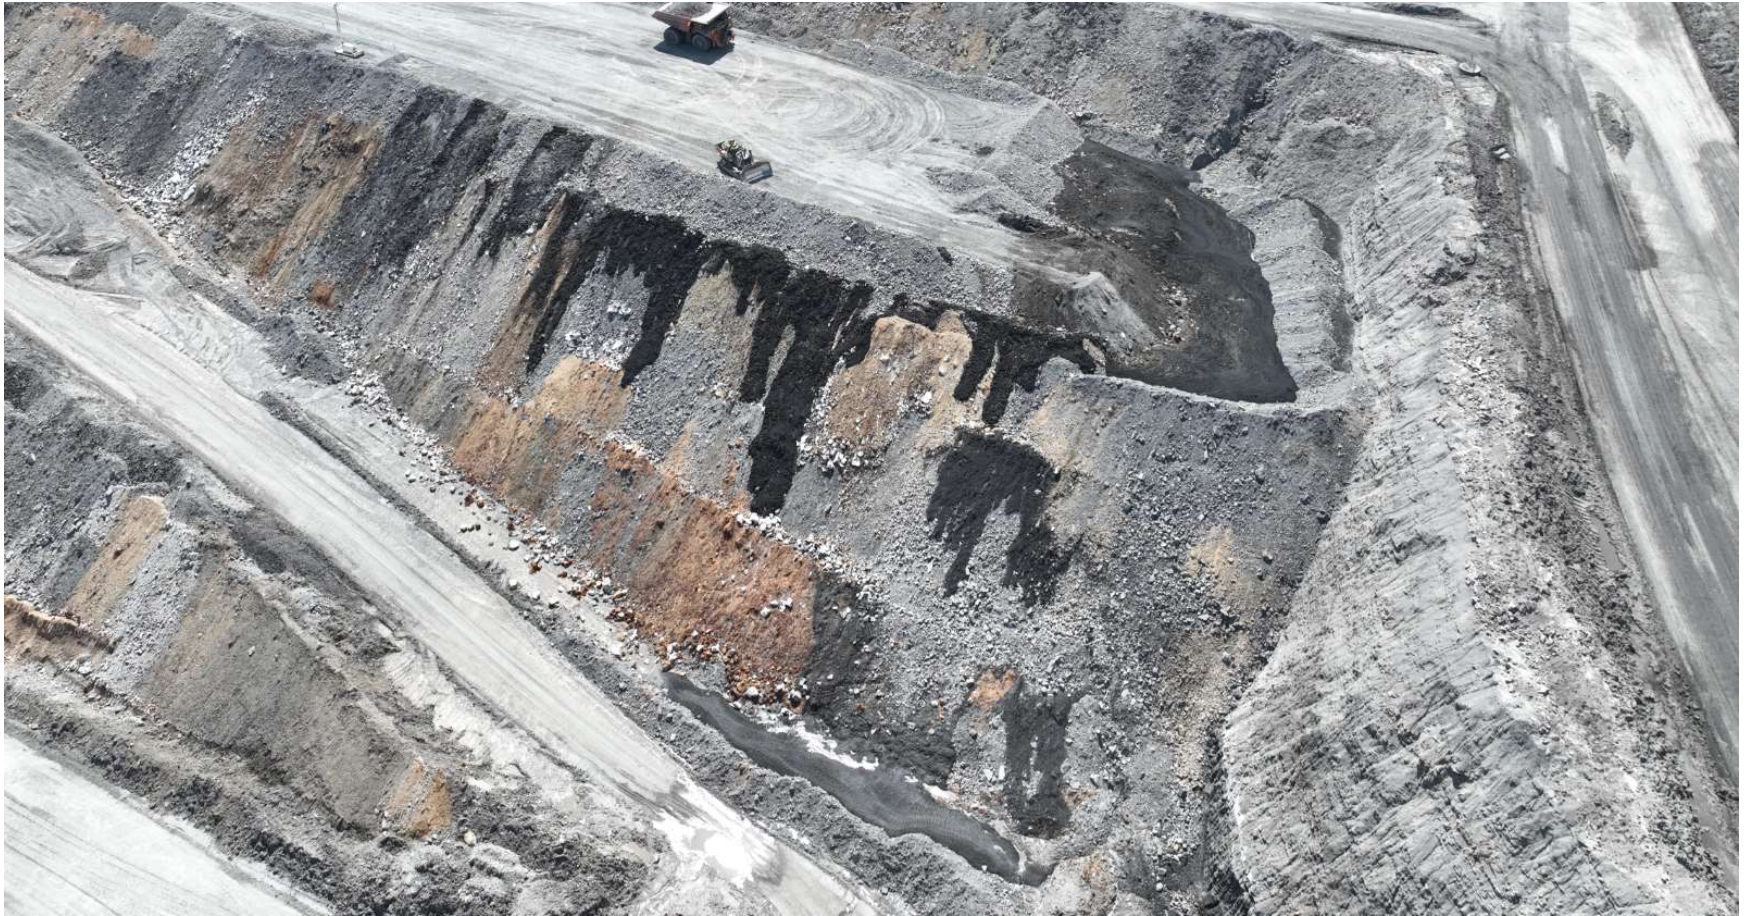
- A weak foundation layer in the base of the dump
- Contact between endwall (insitu) and reject has elevated pore pressures/weakened material strengths
- Hard-packed road + in-situ bench (the base of the dump) created differential contact and limited drainage
- Construction of the base of the dump was during very wet conditions
