Investigation Summary - Operator falls from dozer

Event - 1000493316

Investigation Summary - T913 Contacts Windrow OP1 Road

Event - 1000521330

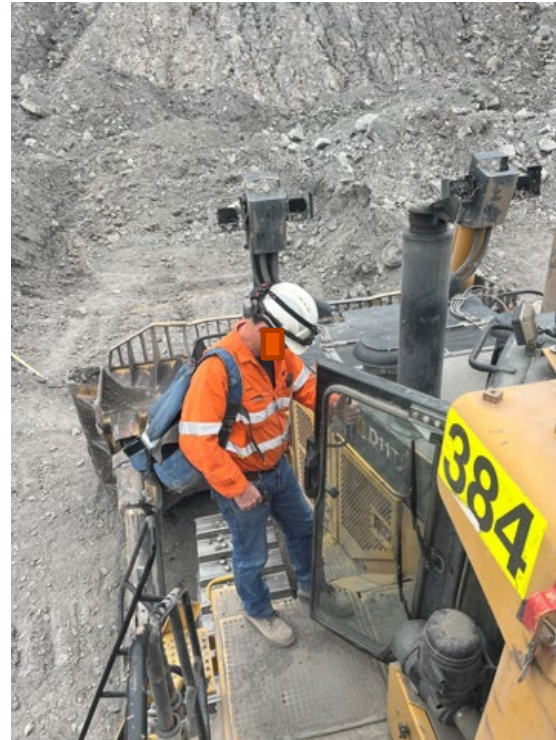
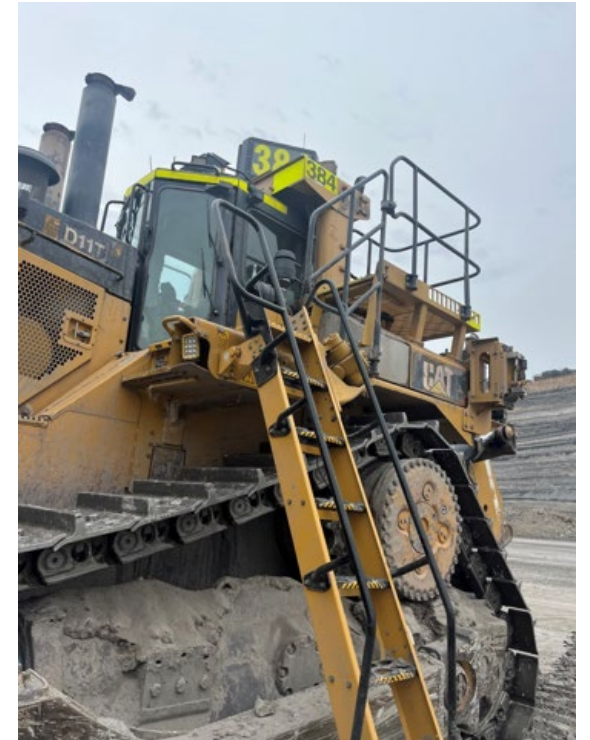
Operator of TRD384 parked up dozer in the darkness as lighting plant was facing the other direction - towards the dump.

Operator of TRD384 stated it was "pitch black", they did not utilise the access lighting / no cap lamp

Operator of TRD384 stepped backwards on the deck rotating in a clockwise position

Operator of TRD384 fell from TRD384 deck.

Operator of TRD384 right foot slipped / missed the small "L shaped" part of deck

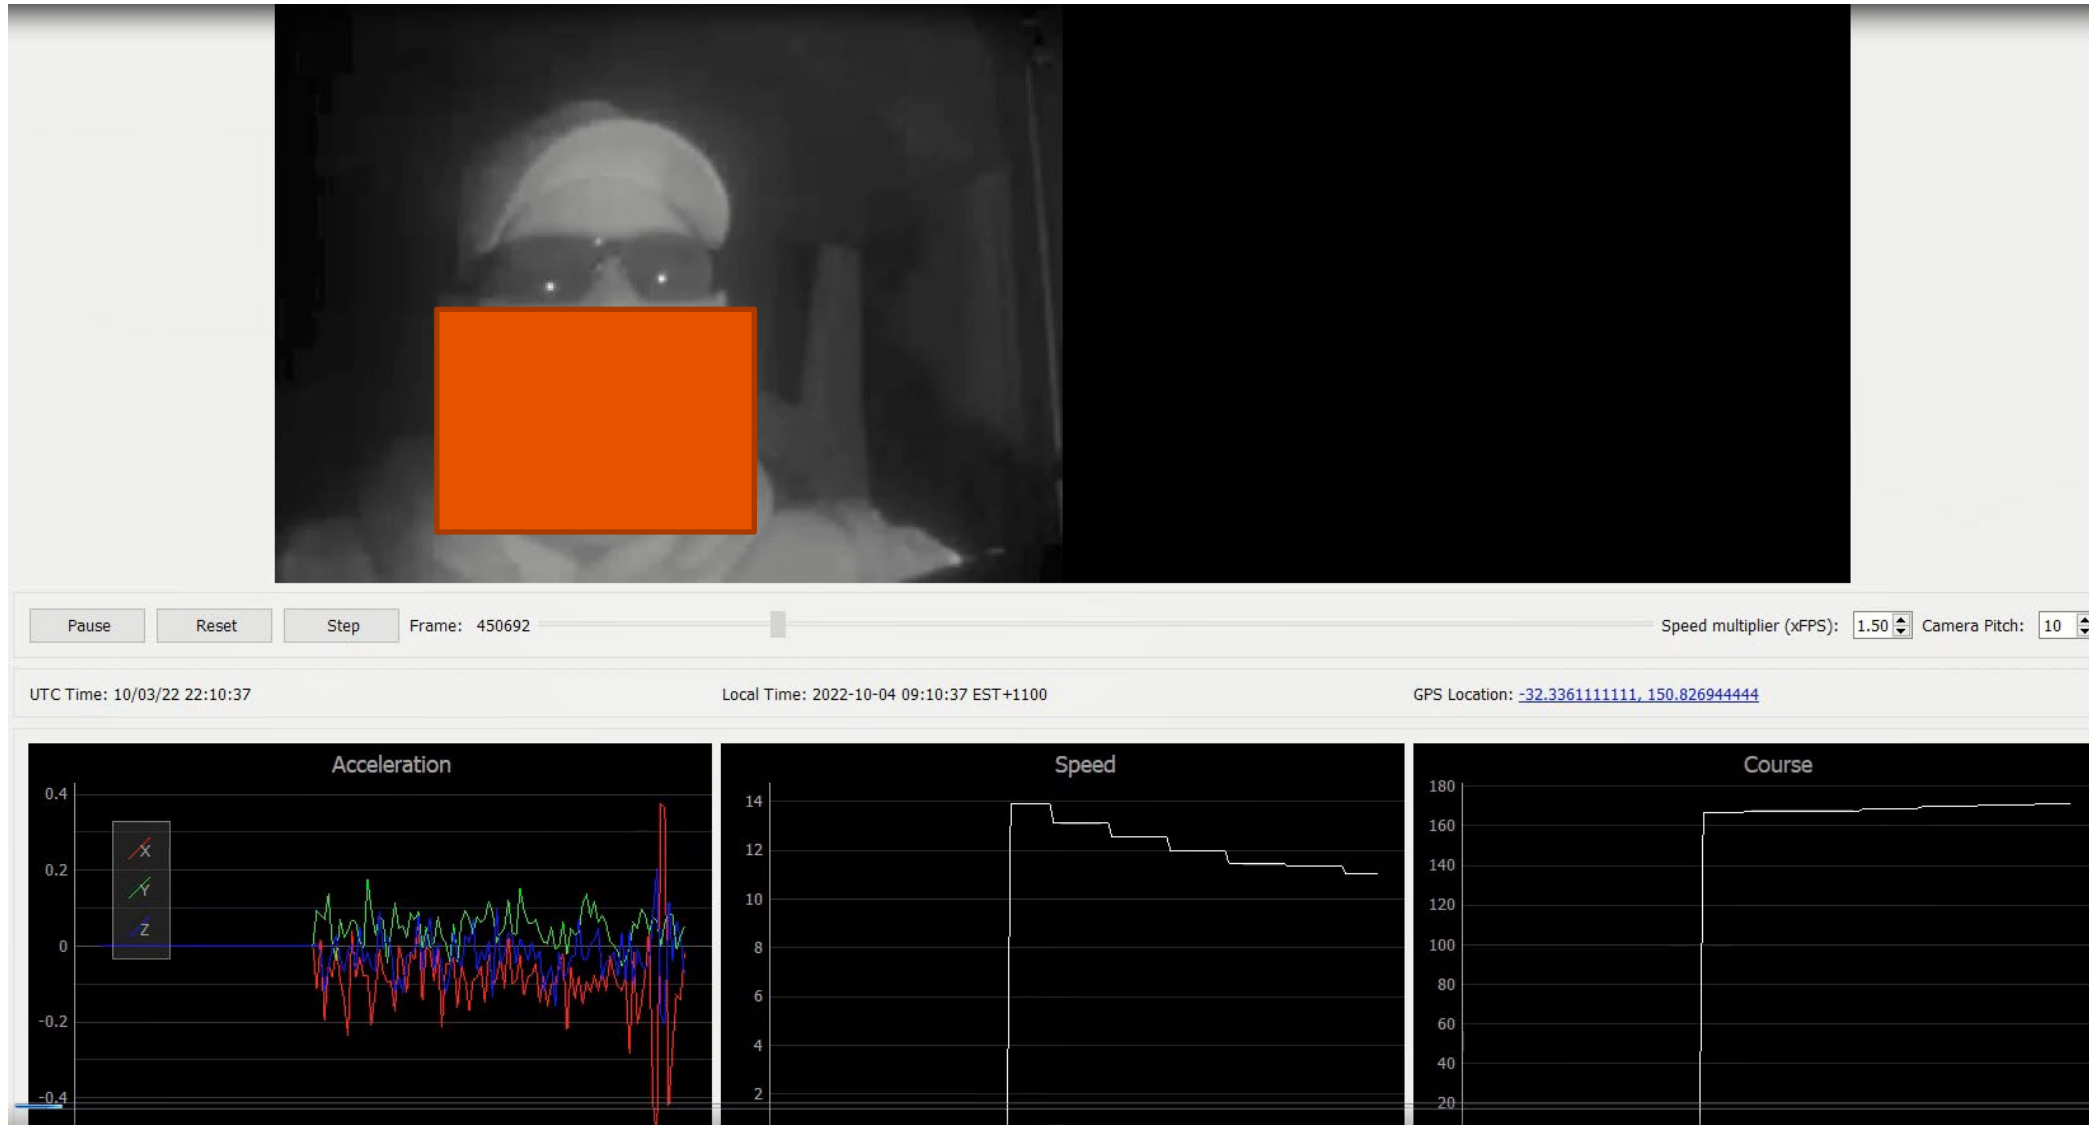
Short video of one of the microsleeep events.
Note dark glasses and IR reflection on lenses
