Quarterly safety report

January to March 2023

Title: Quarterly safety report – January to March 2023

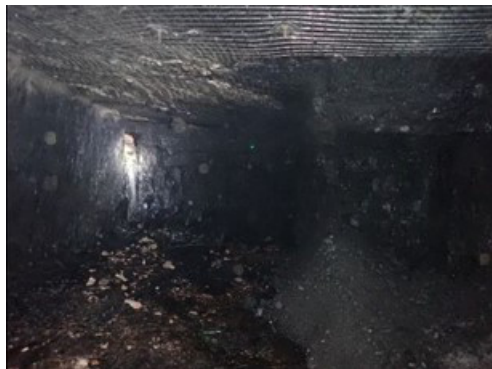
Dangerous incident | IncNot0044289 – Fault-related void containing water exposed

Summary: While mining in a development panel, a continuous miner exposed a fault-related void that contained water. The water entered the working face. The inflow of water slowed significantly by the end of the shift.

Picture 6.
Rib where water flowed into heading.

Comments to industry: Mine operators should review their procedures for advancing towards a known geological structure to ensure the presence of gas and/or water has been considered and controls are in place.

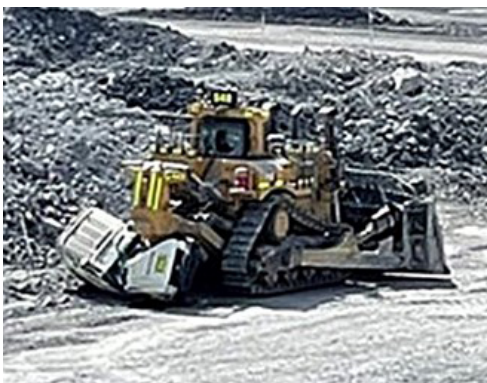
Dangerous incident | IncNot0043703 – Dozer crushed light vehicle

Summary: A worker was tasked with creating a park up area in a new work area at an open cut coal mine. The operator of a dozer reversed into and crushed the light vehicle they drove to the area. There were no other workers in the vehicle or working in the area at the time.

Picture 7.
Dozer impacted light vehicle.

Comments to industry: Mines should review their park up procedures when workers are accessing parts of the mine without designated park up areas. Operators must always remain vigilant and focused on the area surrounding the machinery they are operating.

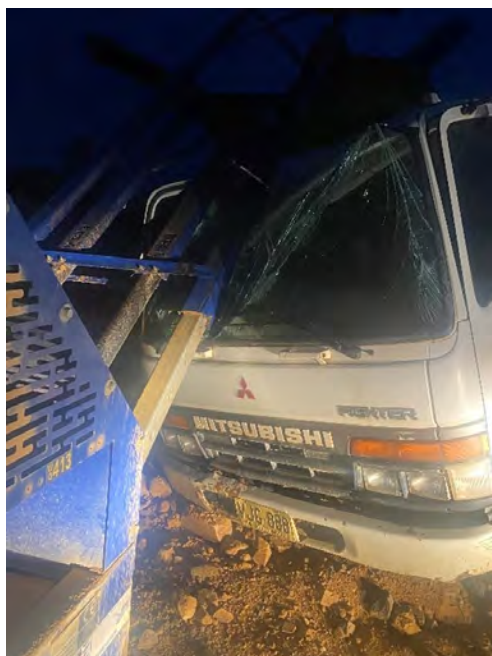
Dangerous incident | IncNot0043912 – Fuel truck rolled during refuelling

Summary: A worker reversed a fuel truck up a grade and parked the truck with the wheels turned. The worker applied the park brake, engaged the PTO for the fuel pump and left the engine running. The truck rolled away when the worker started refuelling. The truck rolled 8 metres, hitting an A frame of a mobile stacker. The worker was exposed to a risk of serious injury.

Picture 8.
Truck rolled hitting crusher.

Comments to industry: Workers should ensure their vehicles are parked appropriately and are fundamentally stable before exiting them. For areas where mobile plant is regularly required to park, level park-up areas should be provided.

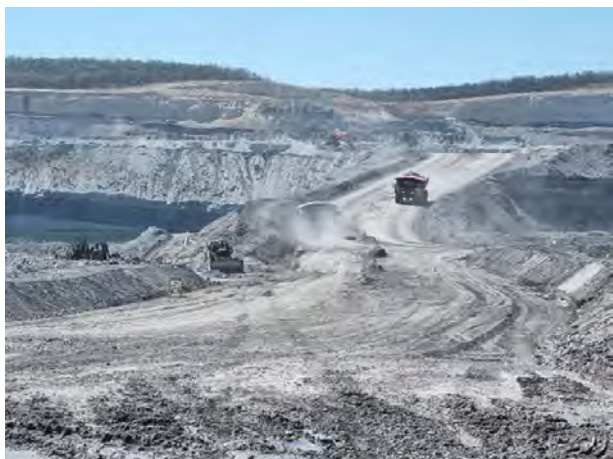
High potential incident | IncNot0043870 – Inoperable dozer rolled after excavator sling broke

Summary: A Caterpillar D10 dozer was inoperable and required towing to an in-pit maintenance area, which was several hundred metres down a ramp. A JHA was completed and required a D11 dozer and a large wheel loader to carry out the task. The D10 dozer would be unmanned for the task. The wheel loader was not available, so a 36-tonne excavator was used instead. The JHA was not reviewed. The task commenced and, in the process, the sling attached to the excavator broke. The inoperable dozer rolled 19 metres until the slack was taken up by the D11 dozer. While the D11 dozer was repositioning, the sling slipped off the ripper. The D10 dozer then rolled approximate 230 metres down a ramp. The dozer stopped when it struck a windrow.

Picture 10.
Travel path and final position of runaway dozer.

Comments to industry: When changes are required to procedures, workers must stop, assess the risk of the changes and raise the matter with their supervisor. When towing mobile plant, the attachment method must be suitably rated with slings securely attached to both vehicles involved. Slings must not be pulled over sharp edges.

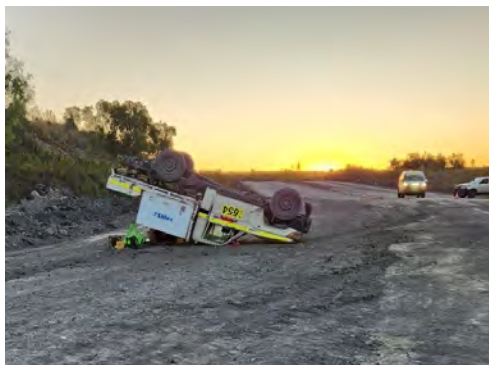
Dangerous incident | IncNot0044034 – Light vehicle rolled after hitting rock

Summary: An apprentice was driving a light vehicle on a haul road when it hit a rock and rolled the vehicle. The sun was in the drivers' eyes at the time of the incident. The worker was uninjured.

Picture 12.
Rolled light vehicle.

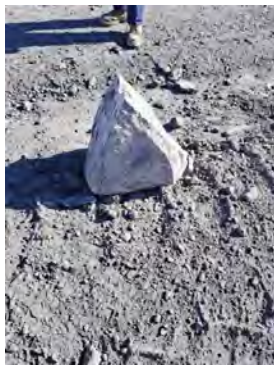
Picture 13.
The rock that the light vehicle struck before rolling.

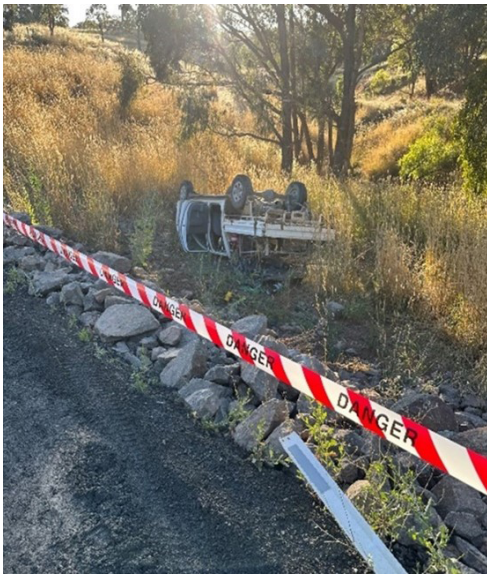
Dangerous incident | IncNot0044036 – Light vehicle rolled in fatigue related incident

Summary: A light vehicle was travelling along an access road at 3.40am when the vehicle left the road and rolled. It is believed that the operator had a fatigue event. The worker exited the vehicle without injury.

Picture 14.
Rolled light vehicle.

Comments to industry: Workers must present as fit-for-work. Fatigue and fitness for work must be managed in accordance with the mine's health control plan. This includes ensuring workers show up to work with adequate sleep and are free of alcohol and drugs. Adequate fatigue breaks should be built into shift patterns and work plans.

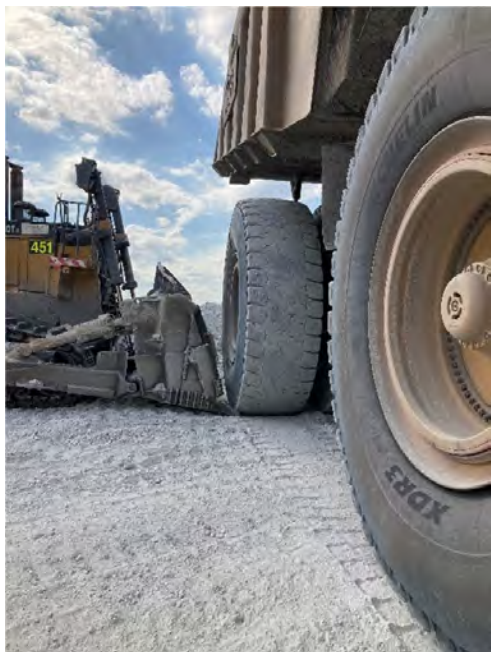
Dangerous incident | IncNot0044061 – Collision between haul truck and dozer

Summary: A dozer was on the left-hand side of a dump. The dozer was stationary. A haul truck operator with 8 weeks' experience approached the tip head and did a U turn before reversing to the dump. The dozer operator attempted to contact the truck operator to warn of their presence but was unsuccessful. The truck's right rear tyre made contact with the front right corner of the blade.

Picture 15.
Truck's right rear tyre impacting the dozer blade.

Comments to industry: Mine operators should continually review the suitability of collision avoidance technology as it evolves, and new products become available.

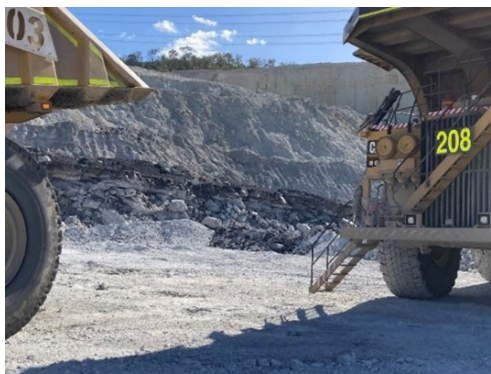
Dangerous incident | IncNot0044100 – Collision between 2 haul trucks

Summary: The operator of a haul truck was trying to park next to a parked haul truck. The operator misjudged and the rear left of the tray hit the front right tray of the truck.

Picture 16.
Impacted front right tray of the haul truck.

Comments to industry: Equipment operators must check their surroundings before parking. Workers must ensure the correct separation distance between equipment is applied when parking and not rush to park up for breaks or shift end. Park-up areas should be designed and constructed to drive through to prevent reverse parking and have adequate lighting and demarcation.

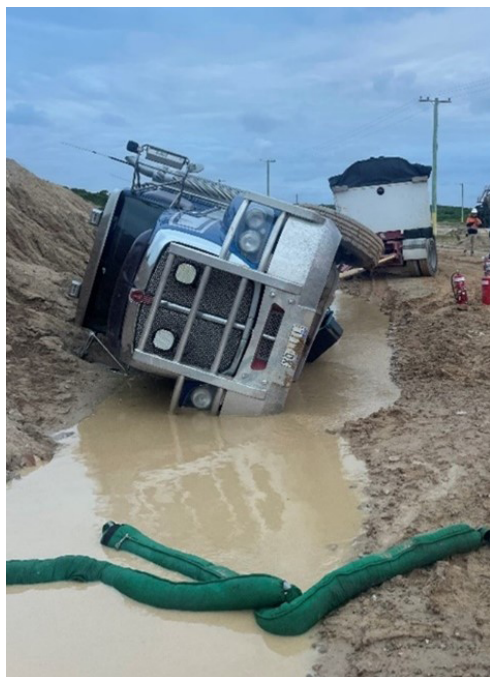
Dangerous incident | IncNot0044140 – Truck slipped into drain and rolled onto side

Summary: A truck and dog were loaded and leaving a quarry on a single lane road. Another truck had stopped on the road, so the first truck tried to drive around it, leaving the roadway. The truck drove into a drain and slipped, rolling onto its side. The driver was unable to climb out of the truck. Emergency services were called to help the driver to exit the vehicle. The driver was not injured.

Picture 17.
Truck after rolling into drain.

Comments to industry: When operating vehicles and machinery, workers must follow procedures related to roads and other vehicle operating areas, in this case, the worker should not have attempted to pass on a single lane road. Mine operators should review bunding and delineation of access roads. Control measures in place around sumps and drains near roads and vehicle operating areas should be reviewed.

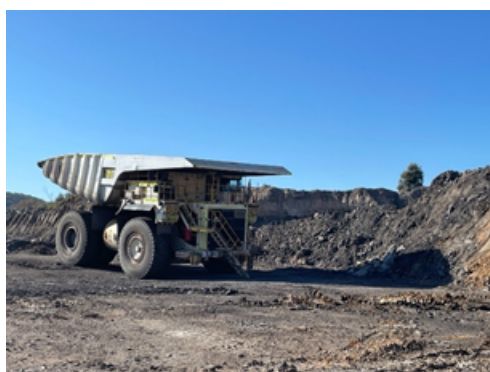
Dangerous incident | IncNot0044124 – Haul truck rolled after park brake applied

Summary: A haul truck was stationary in a queue for a digger when a ladder alarm sounded in the cabin. The operator contacted the workshop and was directed to shut down the truck and isolate it. The operator applied the park brake and exited the cabin. A second alarm sounded. The operator sought further advice from the workshop and was directed to isolate the truck. The operator reached the ground and once the truck was isolated, it began to roll forward. The operator then climbed back up the stairs, entered the cabin and applied the service brake, which needed to be held on with the park-brake activated.

Picture 18.
Final position of truck after truck rolled forward.

Comments to industry: Safety alert [SA23-01 Unintended movement of haul truck](#) was published regarding this incident.

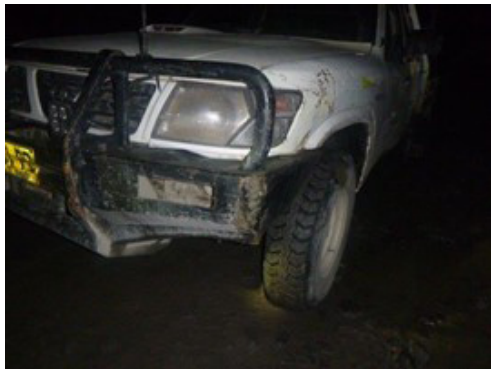
Dangerous incident | IncNot0044166 – Light vehicle hit wall on decline

Summary: A light vehicle was driving down a decline when the vehicle contacted the wall. Preliminary information suggests an issue with the brakes. No workers suffered any injuries.

Picture 19.
Contact point of vehicle with wall.

Comments to industry: Vehicles need to be fit-for-purpose with regular maintenance and inspection systems in place. This must include critical systems such as steering and brakes.

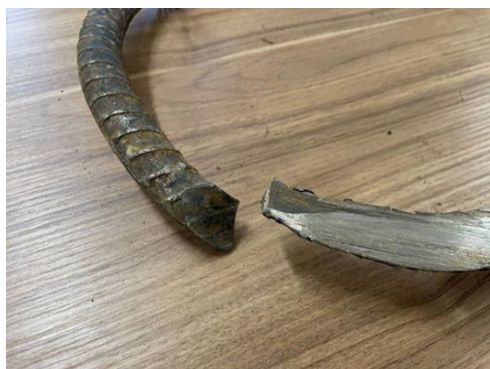
High potential incident | IncNot0043767 – Ignition of methane gas

Summary: An ignition of methane gas occurred on a longwall face. The flames self-extinguished after several seconds. The investigation identified the causal factors being a rib bolt jammed in the bottom race of the armoured face conveyor (AFC) as the ignition source and a floor break emitting methane gas in the immediate area.

Picture 24.
Rib bolt recovered from the bottom race.

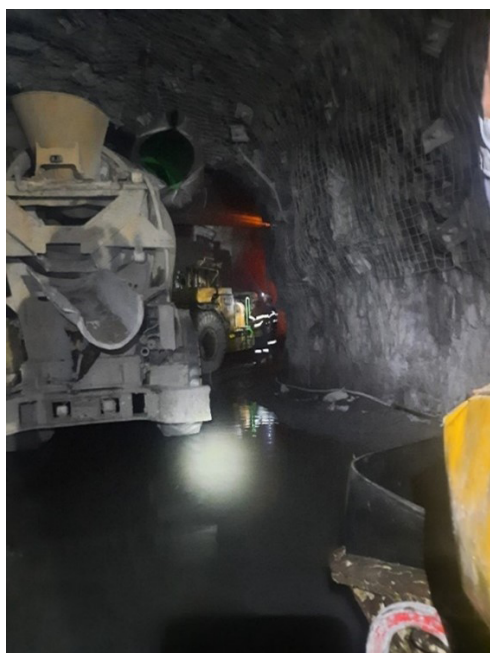
High potential incident | IncNot0043970 – Fire in engine bay of shotcrete rig

Summary: A shotcrete rig was set up to spray in an ore drive. As the agitator reversed into position behind the shotcrete rig, the shotcrete rig operator noticed a 200 mm high flame in the engine bay above the turbo. The shotcrete rig operator activated the emergency stop and the fire suppression system using the rear activation point on the agitator. The fire suppression system extinguished the flames and a hand-held fire extinguisher was also deployed as a precaution.

Picture 27.
Agitator after the fire was extinguished.

Comments to industry: Mine operators must have systems in place to ensure that mobile plant is cleaned following a service to ensure that flammable substances are removed from potential heat sources.

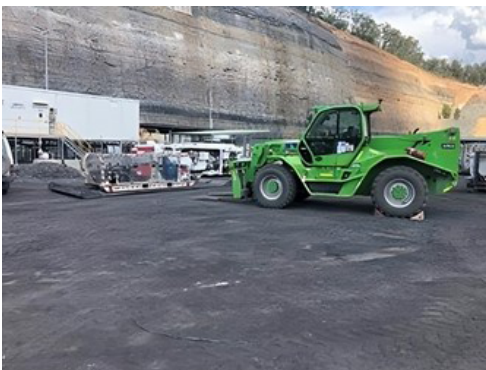
Dangerous incident | IncNot0043978 – Uncontrolled movement

Summary: A worker was operating a Merlo JVE03 loading salvage pack onto 6m sled. While operating the raise function, it became stuck, causing the load to raise. Operating the down function stopped the load. Releasing the down function raised the load again. The load was lowered to the ground. After placing the load on the ground, the operator did a function test again and the event repeated. The machine was placed out of service and the incident scene was secured.

Picture 31.
Telehandler involved in unplanned movement.

Comments to industry: Uncontrolled vehicle movements like this one are a known risk. Mine operators should consider the risk of uncontrolled machine movements when developing controls for the safe egress of pedestrians in and around mobile plant operating areas.

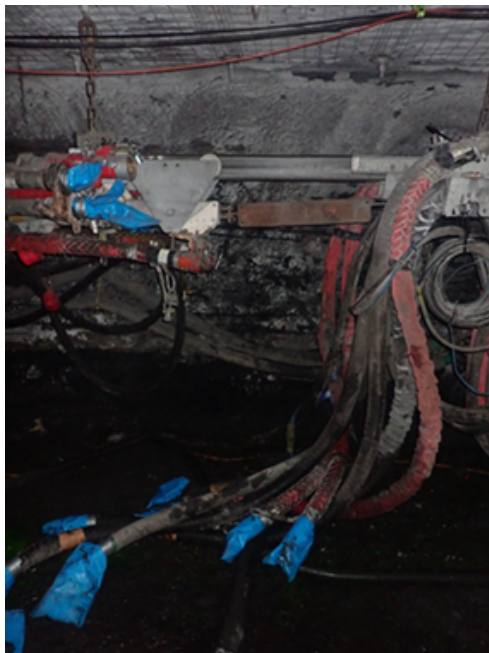
Dangerous incident | IncNot0043983 – Worker injured by uncontrolled air hose

Summary: A worker was disconnecting compressed air lines while removing a monorail section as part of a longwall relocation. The worker removed a staple on an air hose when the hose whipped around, knocking off the worker's helmet and hitting him into the rib. The worker also suffered abrasions that were treated at hospital. The investigation identified that the air pressure had been isolated but not dissipated.

Picture 32.
Break point in monorail where worker was struck by compressed air hose.

Comments to industry: Inexperienced operators must have appropriate training and supervision. Systems of work should be unambiguous when it comes to discharging stored energy before work is undertaken.

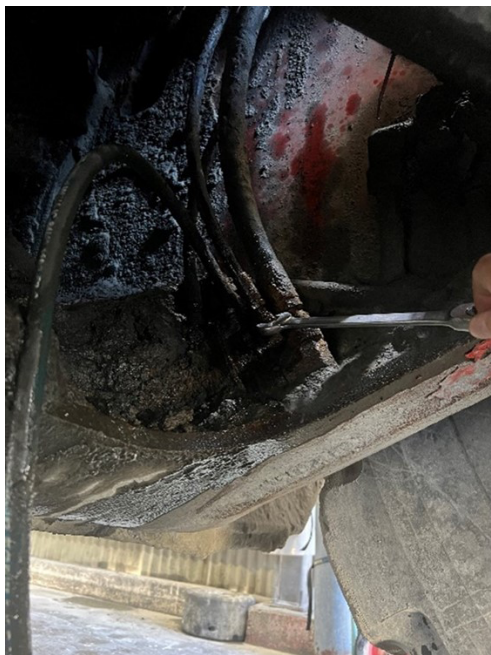
Dangerous incident | IncNot0044173 – High pressure hydraulic oil spray

Summary: A fourth year mechanical apprentice was removing hoses on the retrieval circuit of a load haul dump (LHD). While undoing a hose, high pressure hydraulic oil sprayed the apprentice’s left arm. The apprentice was cleared of injury.

Picture 34.
Hoses being worked on at the time of the incident.

Comments to industry: Workers must ensure hydraulic systems are isolated and stored pressure is released before working on hydraulic systems. Apprentices must be supervised and trained in workplace tasks.

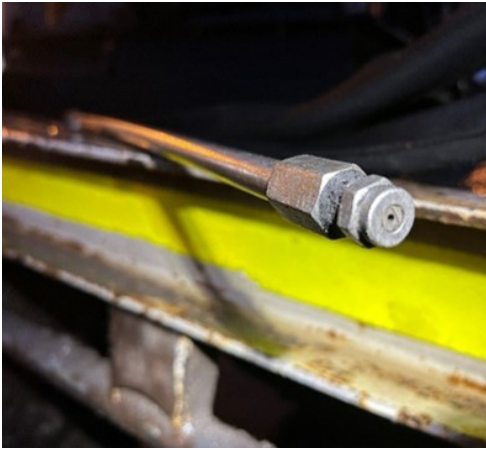
Dangerous incident | IncNot0044382 – Block pressure washer nozzle

Summary: While using a pressure washer, the nozzle became blocked. The operator used their thumb to clean the tip. The operator was then hit by the stored water pressure in the lance. The operator was sent to hospital and cleared of any injury.

Picture 36.
Nozzle of pressure washer.

Comments to industry: Workers must be trained and competent in the use of pressure washing equipment. Training and procedures must include awareness regarding fluid injection injuries.
