Quarterly safety report

April to June 2023

Published by NSW Resources Regulator
Title: Quarterly safety report – April to June 2023
First published: August 2023
Authorised by: Executive Director, NSW Resources Regulator
CM9 reference: RDOC23/151558

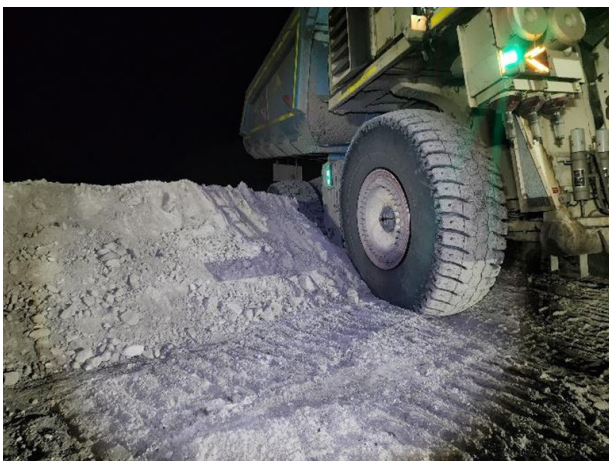
Picture 3.
The scene following the incident

Dangerous incident | IncNot0044569 – Truck driven through a windrow

Summary: The driver of a haul truck was reversing up to dump a load and drove through the dump's windrow. The worker safely exited the truck, and the truck was secured.

Comments to industry: Workers should always approach bunds with their truck square to the bund. Workers must not use bunds to stop trucks when reversing to dumps.

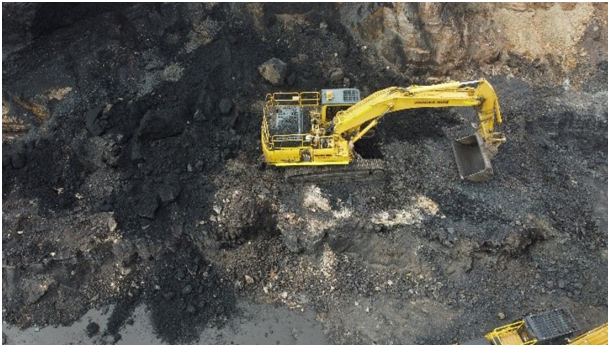
Picture 4.
The scene following the incident

Dangerous incident | IncNot0044701 – Bench collapses onto excavator

Summary: An excavator was being used to dig out a sediment dam. The bench above the excavator let go, releasing about 20 tonnes of consolidated fines onto the excavator. The operator was able to tram the excavator clear of the material and was not injured. The task was being carried out under a generic procedure.

Comments to industry: When working under benches and walls, a safe stand-off distance should be defined, communicated with workers and maintained throughout the task. Supervisors should increase the frequency of inspections when workers are conducting tasks near benches. Specific task risk assessments and procedures should be used and include assessment of the work environment.

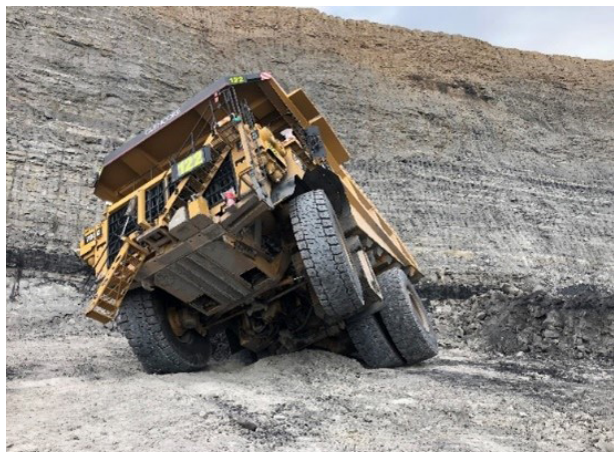
Picture 7.
The scene following the incident

Dangerous incident | IncNot0044839 – Truck sinks when old workings collapse

Summary: After being loaded, a haul truck moved off from a dig face. The area being mined was directly over underground workings. As the truck drove over an underground intersection, the ground slumped underneath the rear left-hand side wheels. The truck came to rest with its front 2 wheels off the ground. The operator remained on the truck and was helped down with an elevated work platform.

Comments to industry: When procedural checks are the only method used to verify a control, this should be documented and recorded. These records should be accessible to supervisors across shifts. Mine operators are reminded the NSW Emergency Management Plan, via the Mine Sub Plan, are required to notify NSW Police as soon as they become aware a rescue is required.

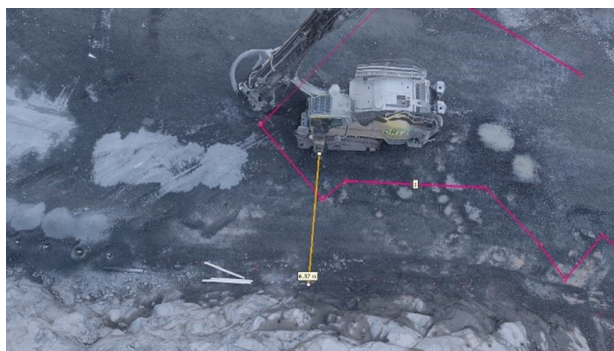
Picture 8.
The scene following the incident

Dangerous incident | IncNot0044813 – Falling material hits drill

Summary: A dozer was working on a main ramp directly above a drill working below. The dozer dislodged some material that fell about 55 metres to the working level below. It is estimated that 100 kg of material fell. The material broke up and 2 of the rocks hit a blast hole drill rig working below. One rock landed on top of a car body of the machine and the other hit the rear window of the operator's cabin, smashing the glass. The worker was off the drill at the time of the impact and was standing about 30 metres away from the drill. Nobody was injured.

Comments to industry: Catch bunds should be in place wherever possible. When work is being carried out above other work areas, no-go zones should be established considering the type of work, height between work areas and suitable stand-off distances. When working against high walls and faces, no work should occur directly above. Autonomous drill rigs remove the workers from the risk of falling objects when working near highwalls and faces.

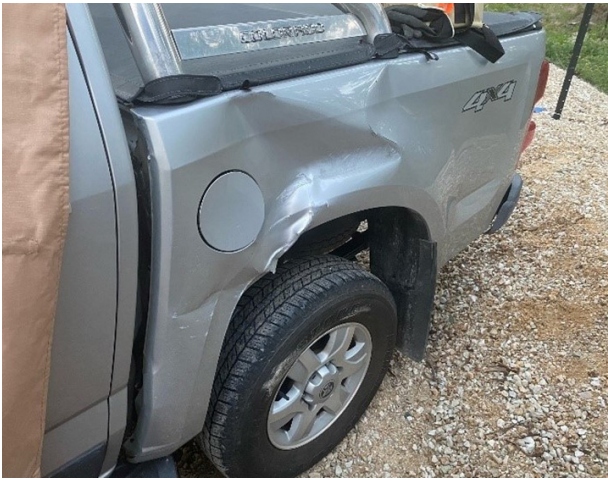
Dangerous incident | IncNot0043703 – Dozer crushed light vehicle

Summary: A man was driving a light-rigid truck and parked in a car park in front of their private vehicle. The truck driver left the truck, which started to roll forward. The driver unsuccessfully tried to get back into the truck and as he tried to jump away, he slipped and the outside rear wheel ran over his ankle. The truck rolled forward hitting his own vehicle and stopped on a bund. He was cleared of any fractures and only suffered minor grazing.

Picture 11.
The point of impact on the private vehicle

Comments to industry: The [Work Health and Safety Act 2011](#) Section 28 requires workers to take reasonable care of their own health and safety and not affect the health and safety of others at work. Workers must also comply with reasonable instructions and procedures of the workplace. Parking fundamentally stable before exiting a vehicle is a reasonable instruction or procedure.

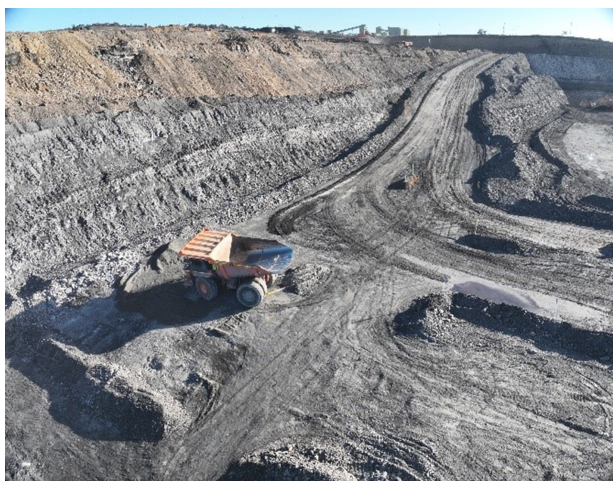
Dangerous incident | IncNot0044878 – Truck slides down ramp through intersection

Summary: A haul truck operator was assigned to a different digger mid-shift. The operator went to travel down a ramp that had not been used since recent wet weather. As the truck was descending the ramp, the rear wheels started to slide. The operator was unable to stop the truck and continued to slide through an intersection. Beyond the intersection was a drill pattern and the operator was concerned this was loaded so steered into the centre bund, stopping the truck.

Picture 16.
The haul truck following the incident

Comments to industry: Mine operators should confirm roads are suitable for use before commencing operations after wet weather. When roads are closed, they should be clearly marked and communicated to workers.

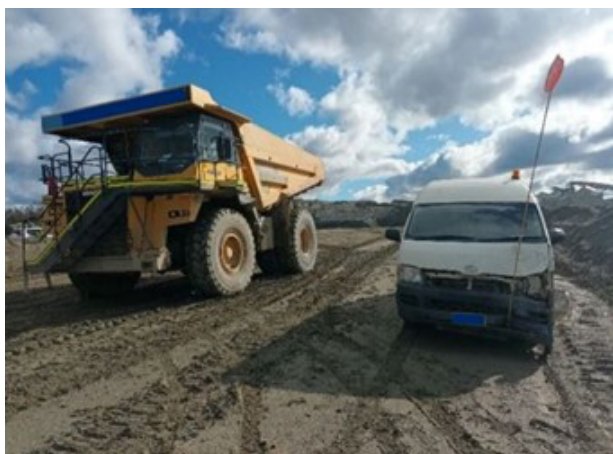
Dangerous incident | IncNot0044935 – Haul truck reverses into van

Summary: An empty haul truck approached a stop sign at a railway crossing. On the other side of the crossing, there was a loaded haul truck approaching. The empty haul truck saw the loaded truck and reversed to give way to the loaded truck and allow more room to cross the railway line. As the empty haul truck reversed, it hit a van that had stopped behind it. The right rear wheel of the empty haul truck hit the front passenger's side of the van. The driver of the van was uninjured.

Picture 18.
The vehicles following the incident

Comments to industry: Mine operators should design sites to separate light and heavy vehicles where possible. Operators should review the separation distances in place at the mine. Supervisors should conduct audits to validate that workers are correctly implementing the controls in the roads or other vehicle operating areas control plans. When reversing, workers must use all available aids such as mirrors, cameras and proximity detection systems to confirm that it is safe.

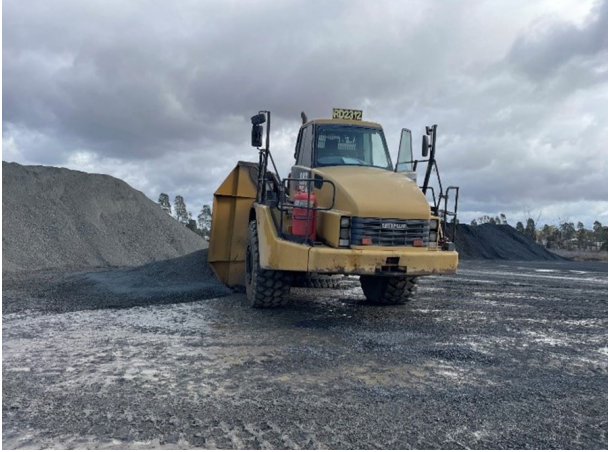
Picture 19.
The scene following the incident

Dangerous incident | IncNot0044966 –Articulated truck tub rolls

Summary: An articulated truck was approaching a stockpile. As the operator started to turn the truck to line up with the stockpile, an alarm started to sound. The tub then rolled. The worker was uninjured.

Comments to industry: When operating articulated equipment workers must drive at appropriate speeds, particularly when negotiating corners and turning the machine around.

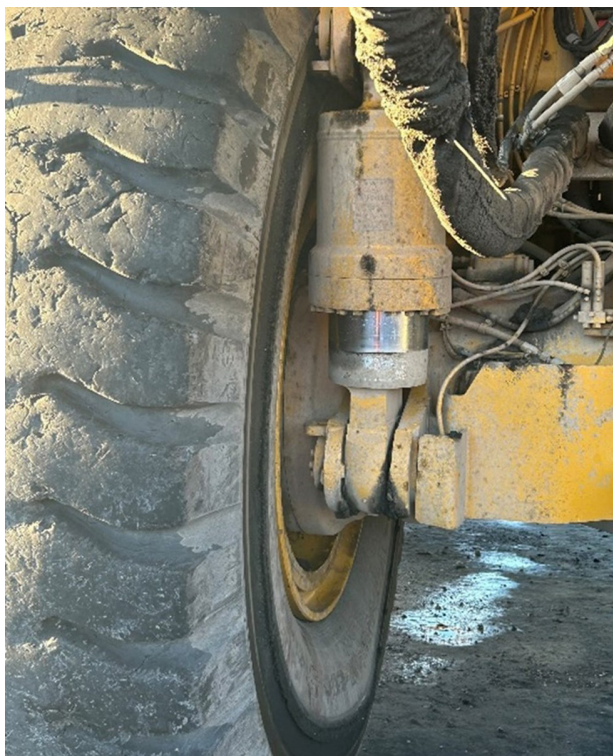
Picture 27.
The inside of position 4 wheel following the incident

Dangerous incident | IncNot0044974 –Incorrect tyre rubs starting fire

Summary: A watercart was fitted with 3 new rims and was sent for a short drive before retorquing the wheels. After a while, the operator noticed a strange smell that became worse. The operator saw smoke coming from the rear of the truck. The operator saw another water cart and called to ask the operator to look at the rear of the truck. At the same time, the operator noticed spots of flames in a line on the haul road behind the truck. The second water cart operator saw flames about one metre high on the inside of position 4 wheel. They used the cannon to extinguish the fire. An emergency was called, and the watercart continued to cool the tyres.

Comments to industry: When changing to a different component supplier or to a different model component, a change management process must be undertaken. This must include checks to confirm compatibility with the equipment that is being fitted and for suitability for the task and duty.
