# MINE SAFETY

# INVESTIGATION UNIT

Serious crush injury to lower leg  
surface of underground coal mine  
21 August 2008

# Crushed by longwall service sleds

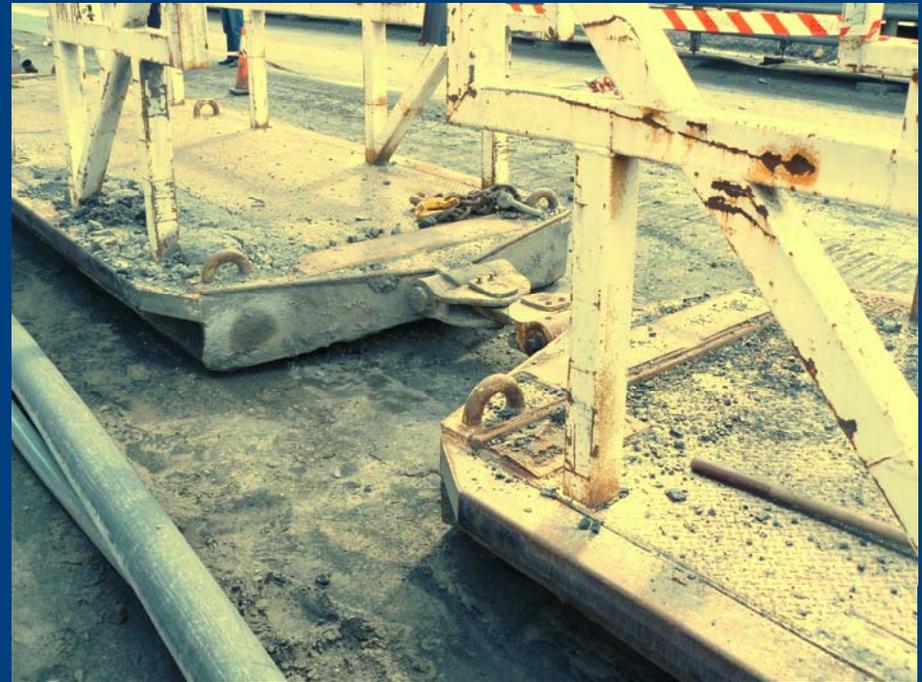
- 21 August 2008
- Incident on the surface of an underground coal mine in Hunter Valley
- Coupling together longwall service sleds
- Man-machine interaction required

- One cassette stationary, other being pushed into place by Juganaut to allow coupling together
- Person lent down to pickup the coupling as they appeared to be aligning perfectly
- As he did so, placed right foot on the ground near the stationary coupling
