INVESTIGATION UNIT

Fatal Injuries from a Recoiling Polyethylene Pipeline
At a Horizontal Directional Drilling Installation on a
Petroleum Assessment Lease in Northern NSW

1 August 2009

Horizontal Directional Drilling Fatality

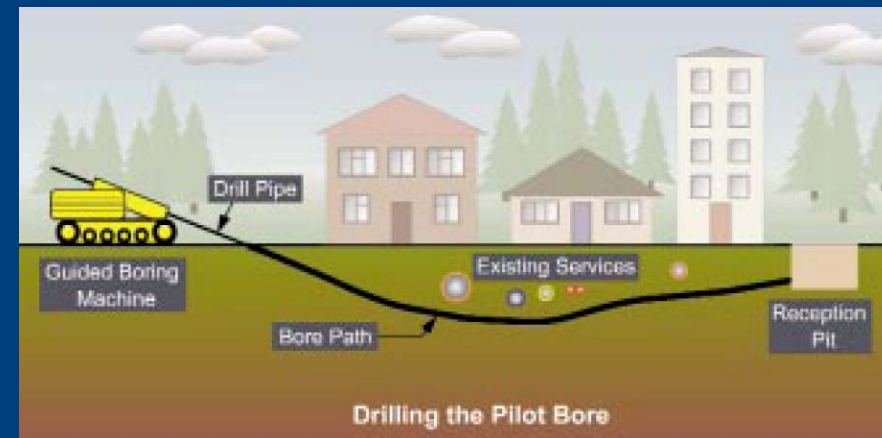
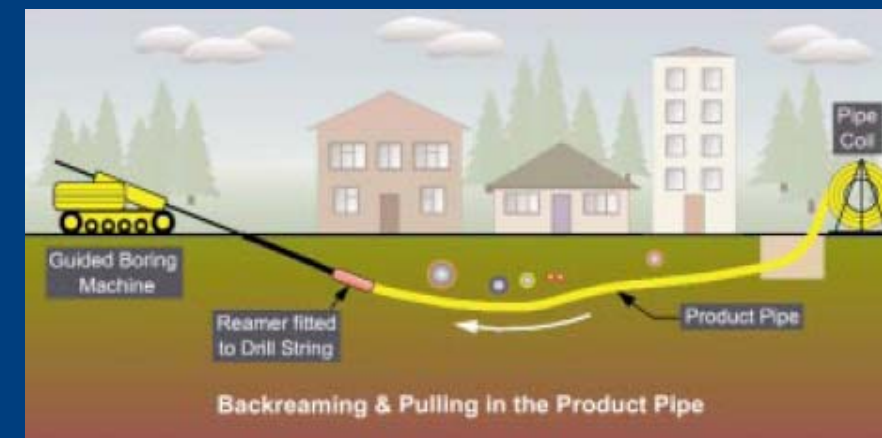
- Trenchless installation of services in all types of ground
- Able to go under existing services and bodies of water
- Pilot hole is steered by controlling line and depth
- Pipeline pulled in behind reaming head on a swivel

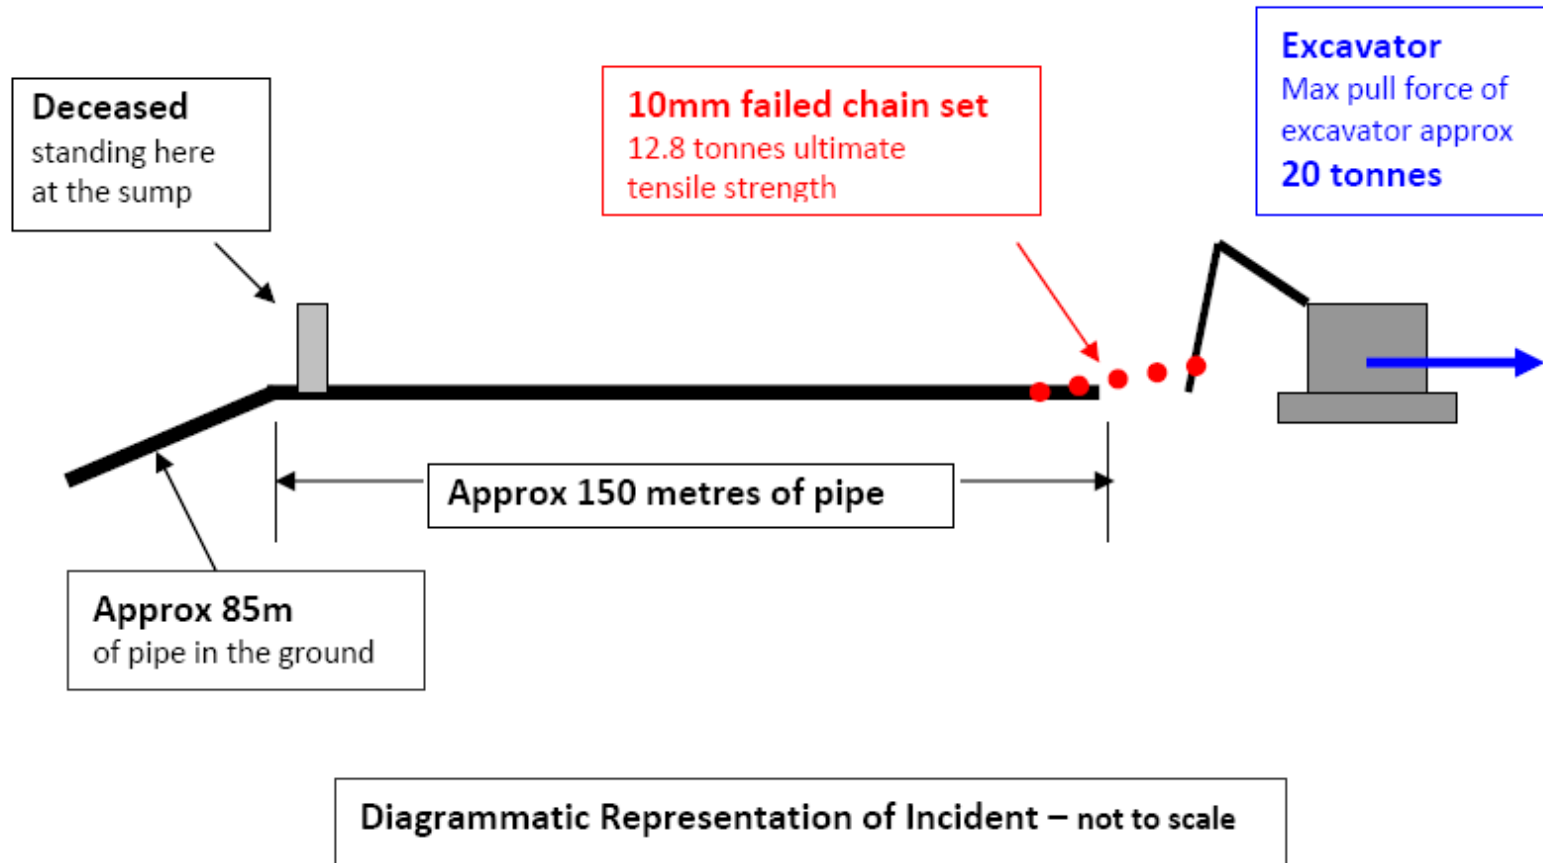
Prior to the incident

- Approximately 145m of pipe had been extracted
- The chains connecting the pipe to the excavator failed
- The pipe recoiled rising up at the pit end
- The bystander was close to the pipe and received a blow to the head

- The victim was found lying at the front of the pit

- Develop safe pulling systems that apply known forces
- Develop pulling systems that minimise stored energy
- Apply safe working zones (exclusion zones) and monitor them
- Consider using towing components that rupture non-violently.
- Use towing systems that are properly designed by competent (engineering) persons
