EXTRACT OF CONSULTANTS' REPORT

Double fatality at Austar Coal Mine on 15 April 2014

Mine Safety Investigation Unit

Title: Double fatality at Austar Coal Mine on 15 April 2014 - Extract of consultant's report

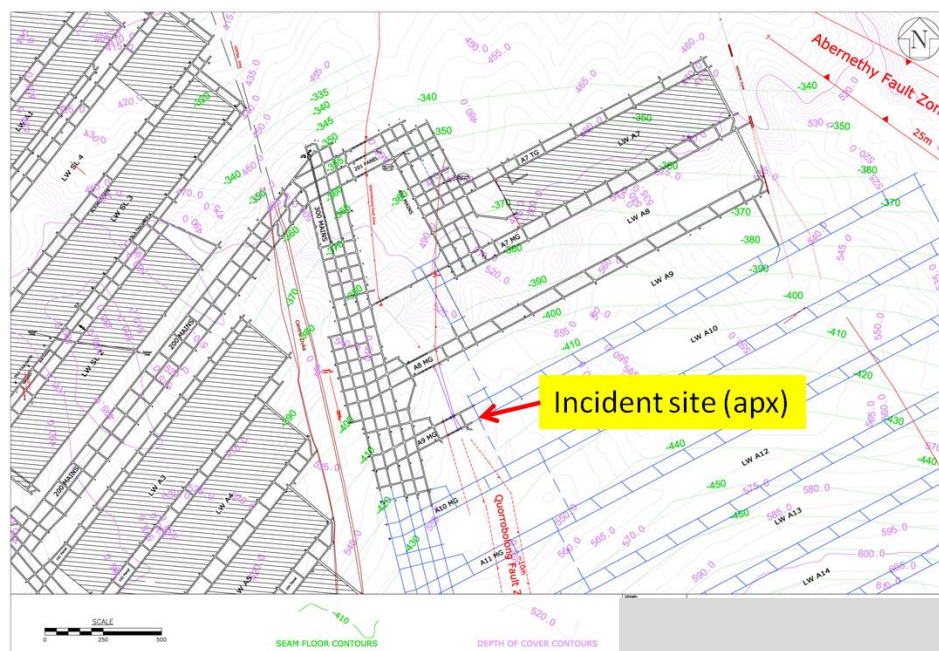
Figure 3 shows the incident site relative to the 200 Mains Development, the 300 Mains Development, and Longwall A7; depth contours throughout this region; and geological structures.

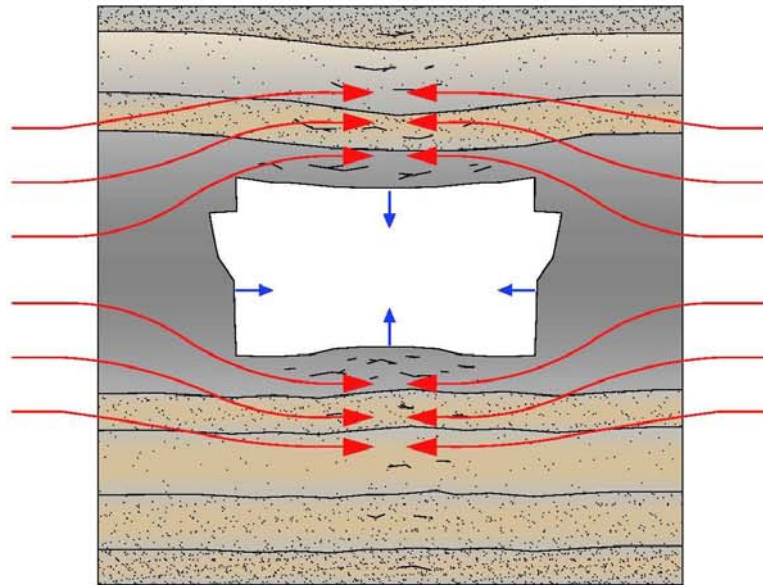
Stage 1 - Roof, Floor and Ribs Buckle During Roadway Development

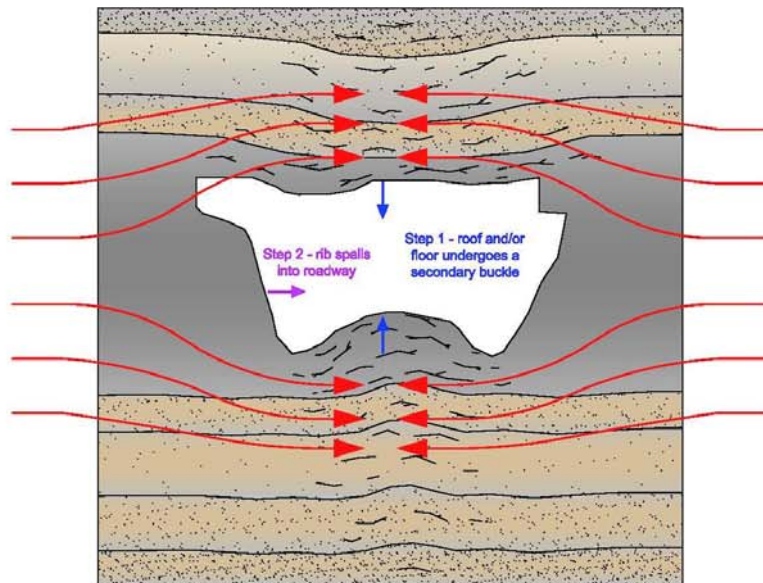
Stage 2 - Roof and/or Floor Store Horizontal Stress and Undergo a Secondary More Violent Buckle Sometime After Roadway Development

6. *At this stage, although it is not clear as to what has caused the horizontal stress to increase and/or the strata to react in such a violent manner, possible contributing factors include (i) the 545m depth of cover¹, (ii) the panel's location between two zones of structural disturbance², (iii) the roadway's angle of intersection with the major horizontal stress, (iv) the sedimentary dyke recorded on the inbye side of D5 intersection³ and the associated increased proximity of more competent strata in the immediate roof and (v) stress notching around the Area 2 longwall goafs.*

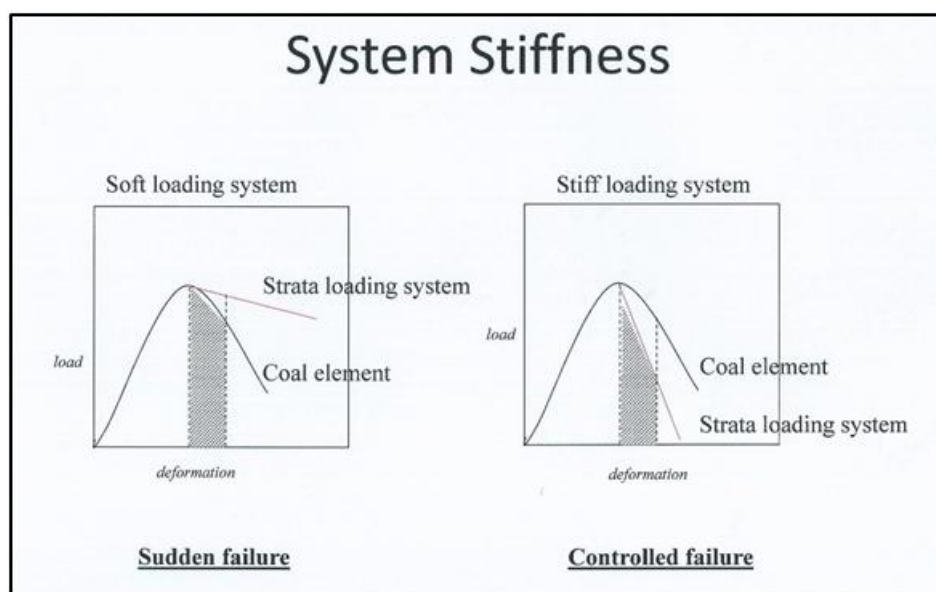
Figure 9: Concept of soft and stiff loading systems.

This figure shows a load-deformation curve for the coal material, as well as a loading curve for the surrounding system (e.g. overburden or floor rock units). The area under a load-deformation curve, for a given increment of deformation, represents a measure of energy involved. Firstly, the coal must be strong enough to store sufficient energy, but if and when it fails, the coal must be stiffer than the surrounding rock mass such that the coal unloading curve can store more energy than the amount of energy being imparted by the strata loading system. In this figure, the area under the unloading curve of the coal, for a given increment of deformation, must be greater than the area under the loading system curve (see right hand controlled failure situation, compared to the left hand sudden failure where the strata is imparting more energy than can be absorbed by the coal).

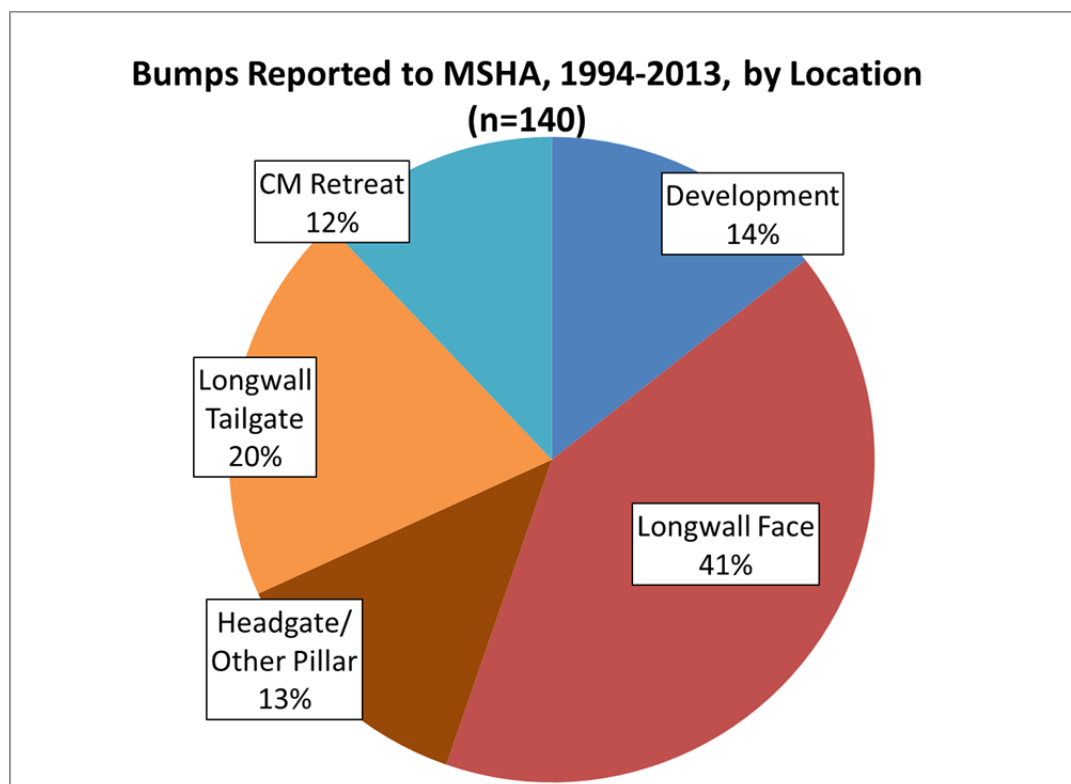
Figure 10. US burst locations reported over period 1994-2013 (after Mark, 2014b).

Notably, only 14% of the reported bursts occurred during development, with 41% occurring on the longwall face. This should not be seen as a reason for complacency regarding the risk of bursts on development in longwall mines. Rather, it is a warning that in areas where bumps or bursts can occur, the longwall face is potentially an even greater risk than development.

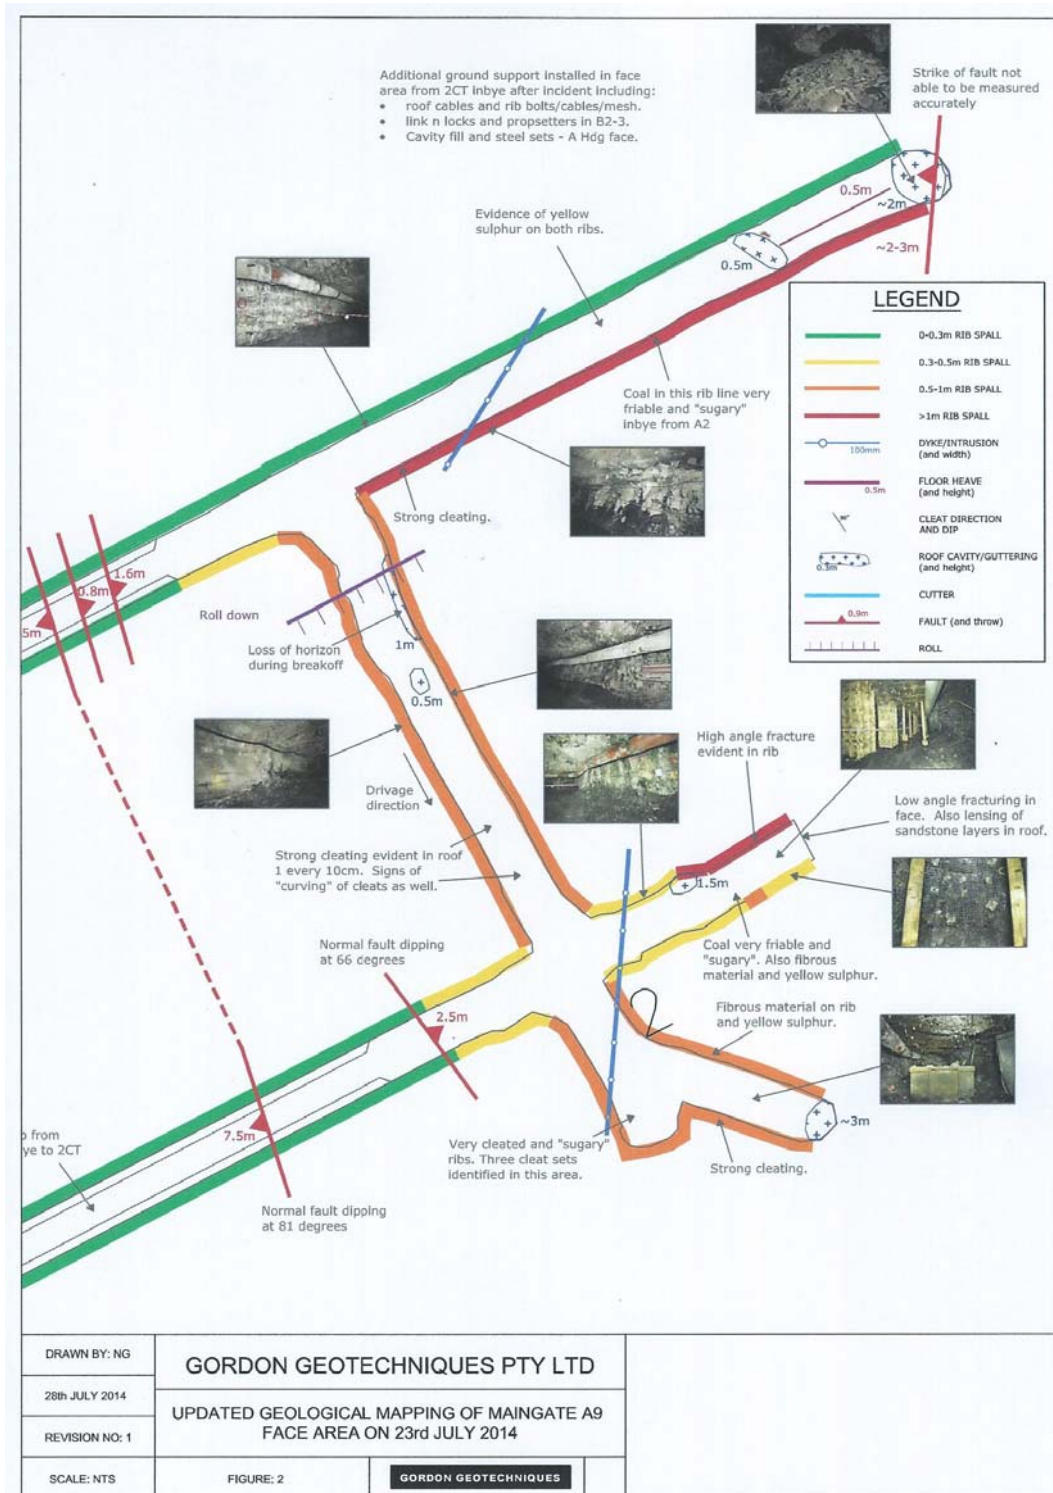
There is no doubt that in areas of structural disturbance such as this, where there is history of pressure bump and possibly burst conditions, forward knowledge of the structural geology

Figure 14. Rib condition and cleat mapping in Maingate A9.

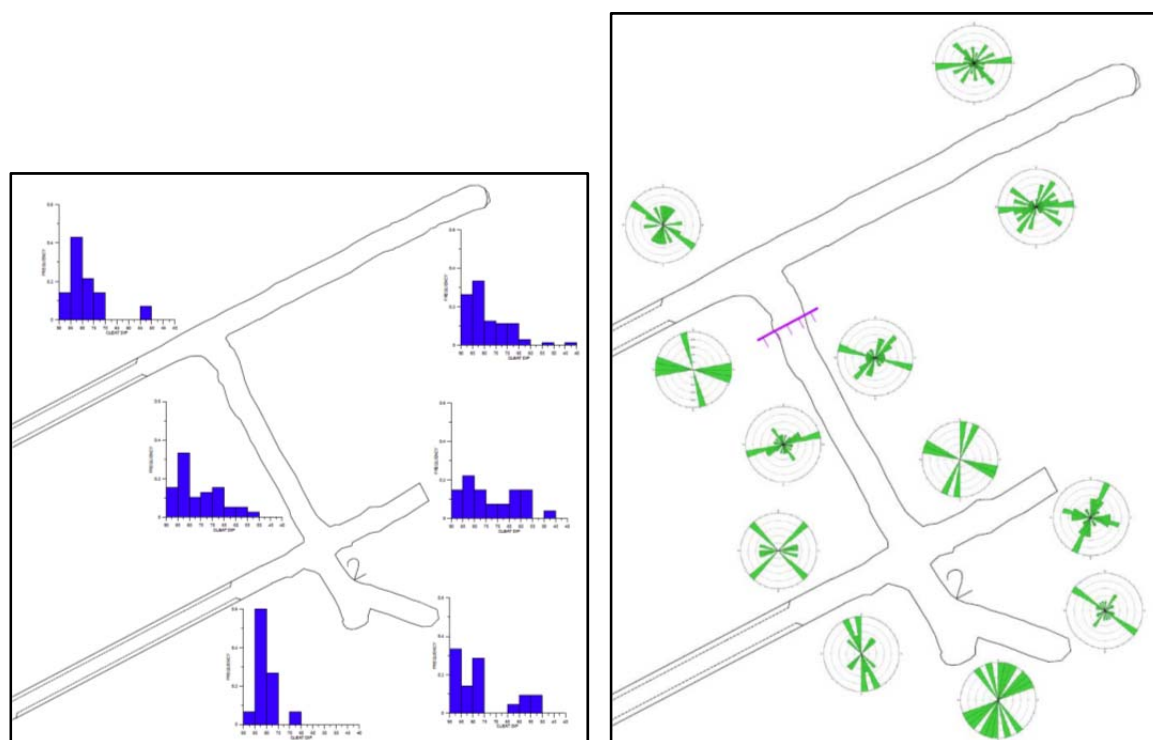
Figure 15. Summary of cleat dip and direction in Maingate A9.
