## Investigation report

Report into the deaths of James Mitchell and Phillip Grant at the Austar Coal Mine, Paxton, NSW on 15 April 2014

Report prepared by the NSW Mine Safety Investigation Unit

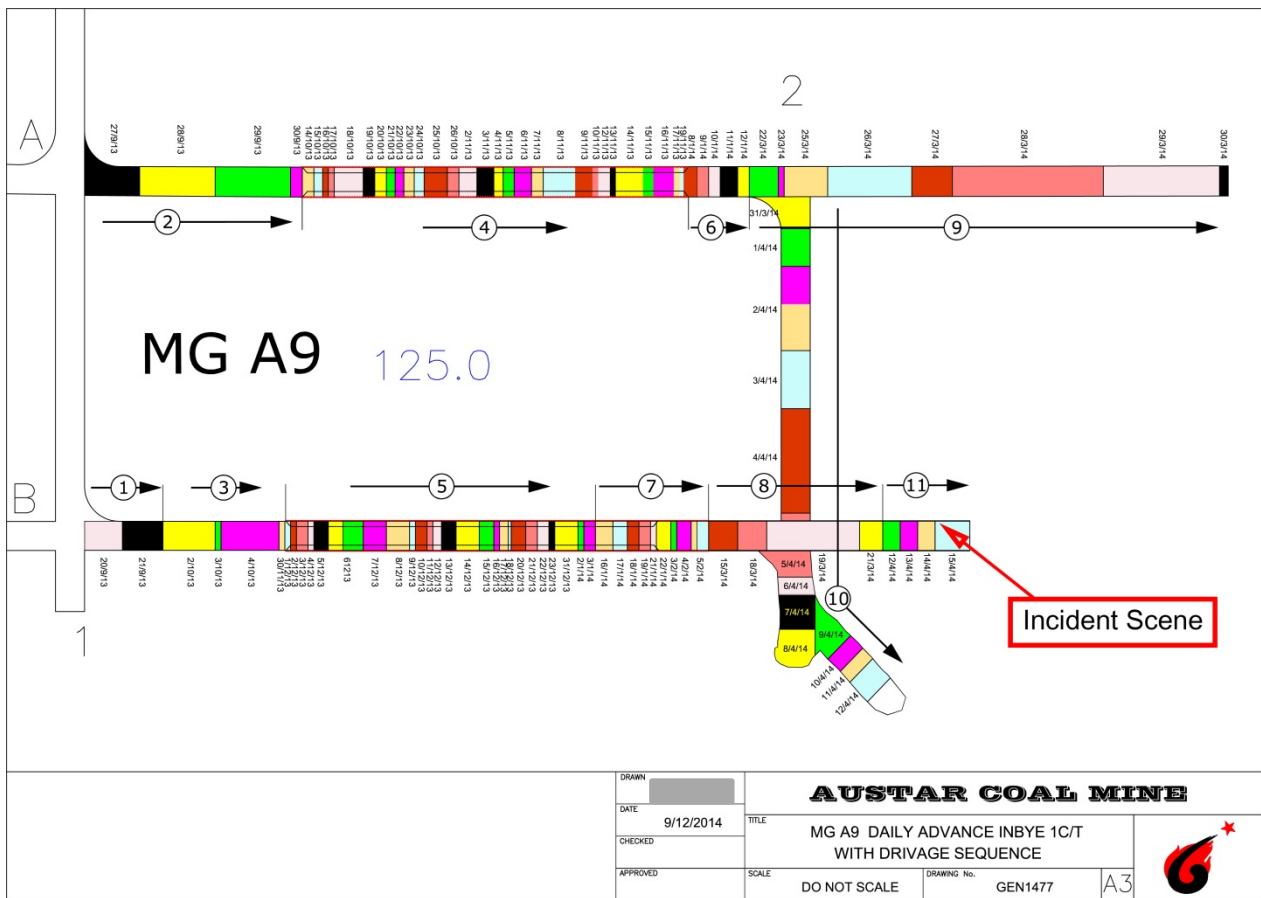
Figure 5 MG A9 daily drirage inbye 1C/T with drivage sequence. 40

Development in MG A9 began in September 2013. Figure 5 below depicts the location of the face of MG A9 at the end of every shift up to the time of the incident. As can be seen below, it took Austar approximately four months to advance 1 cut-through.

The reason for the slow advance between one cut through and two cut through was that a drift of approximately of 60 metres<sup>41</sup> was driven to breach the Quorrobolong fault that had a vertical displacement of 7.5 metres. Once this was driven, the coal seam was intersected and A and B headings were driven in coal, at a distance of approximately 20 metres to 2 cut through. Heading A then advanced until it intersected with an unanticipated fault. The unexpected fault was estimated to be a three metre upthrow fault trending south. This fault was not anticipated in the mine’s planning and fell at the juncture of the next intersection (3 cut through) where it was planned that the take-off road for longwall MG A8 would intersect Heading A. Figure 6 below shows the fault intersected in Heading A.

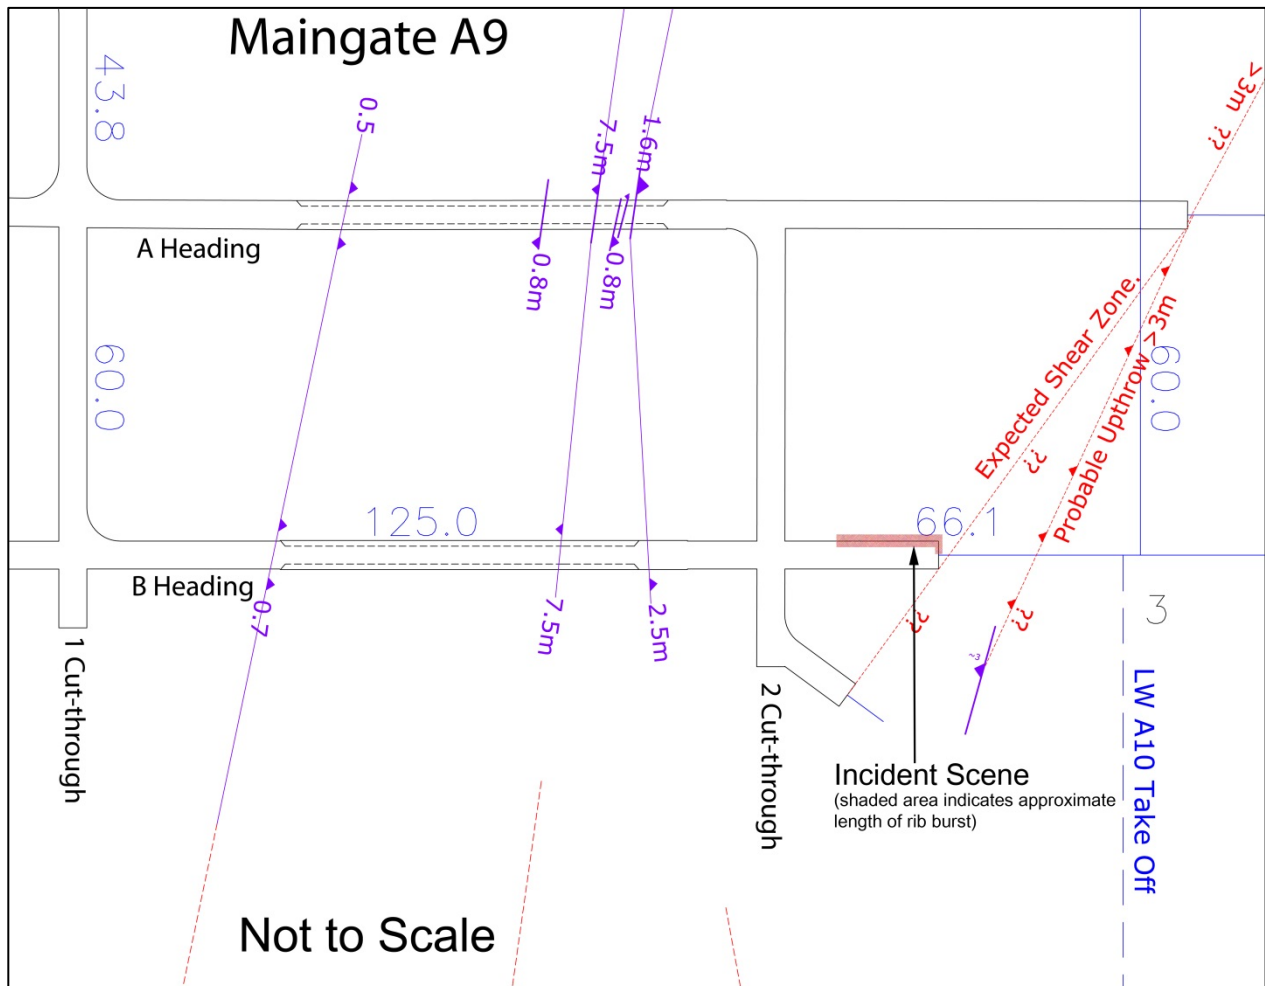
Figure 10 Plan showing layout and some geological features of MG A9.<sup>47</sup>

Figure 10 shows the incident scene in MG A9. It also depicts the faulting between 1 cut through and 2 cut through and the anticipated location of the fault struck in Heading A inbye of 2 cut through.

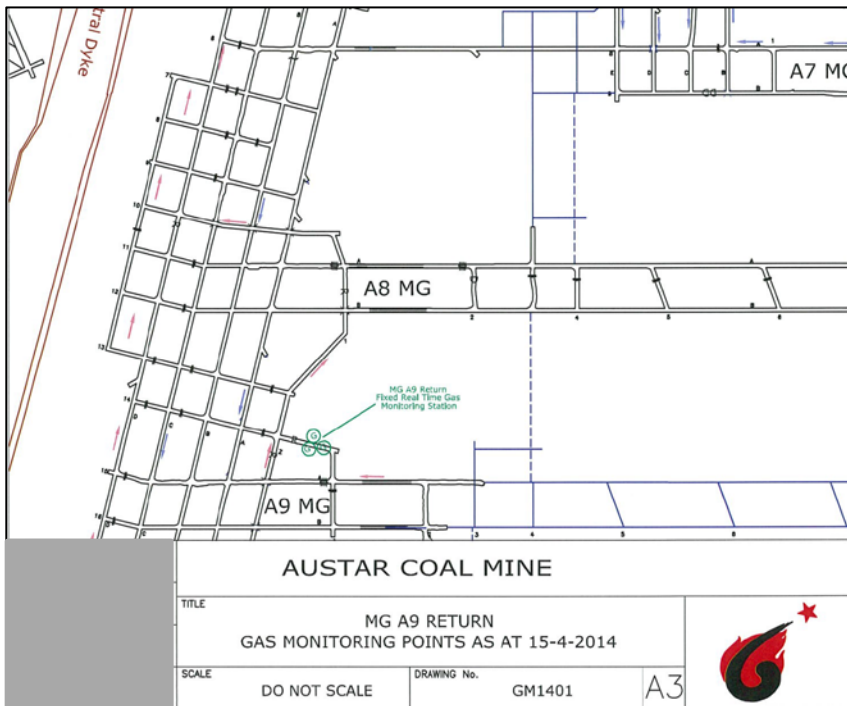
Figure 16 Austar Coal mine MG A9 gas monitoring points.<sup>70</sup>

Figure 16 below shows the location of the fixed real time monitors in the return airways at the outbye end of MG A9. Data from these monitors and from the tube bundle monitoring point 13 located outbye at the up-cast shaft, show relatively low and constant levels of CO<sub>2</sub> and CH<sub>4</sub> before, during and after the incident.

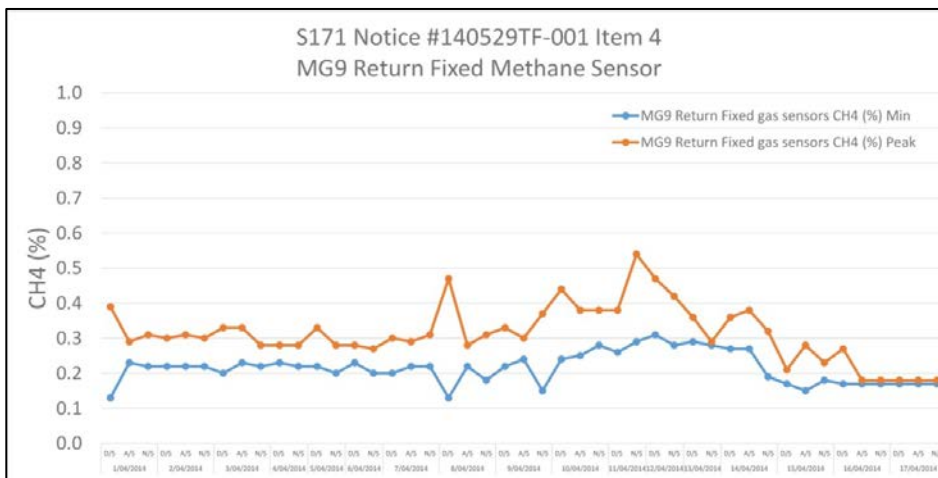
Figure 17 MG A9 return fixed methane sensor.<sup>71</sup>

Figures 17, 18, 19 and 20 below graph the readings of CH<sub>4</sub>, CO<sub>2</sub> and O<sub>2</sub> outbye of MG A9 for the period from 1 April 2014 through to 17 April 2014. As can be seen, there are no elevated readings or unusual spikes within the outbye gas monitoring system.

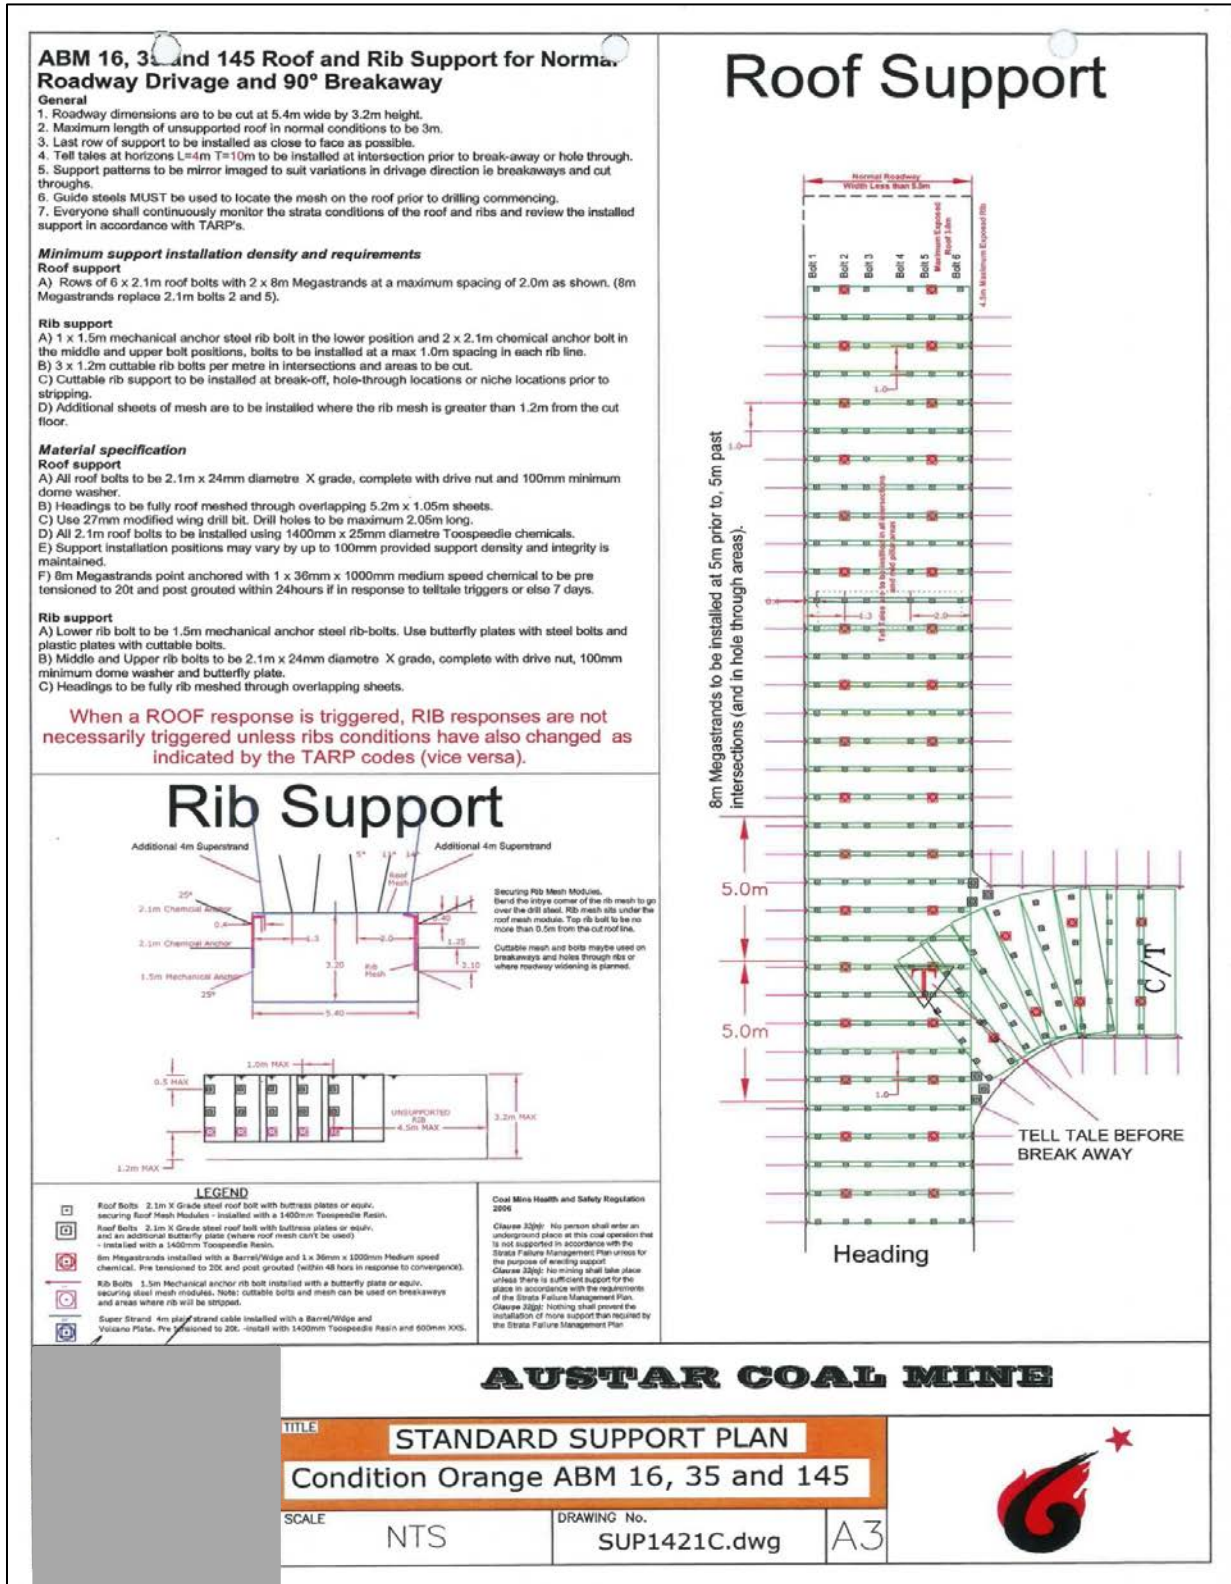
Figure 21 Condition orange standard support plan.<sup>76</sup>

At the time of the incident, the ribs were being supported to a standard set out in the mine's roadway support rules. The required standards for supporting the rib and roadway in the mine are shown below in Figures 21 and 22.

All witnesses spoken to after the incident that had observed the scene confirmed the view that the rib supports they had observed among the debris after the incident had no sign of mechanical failure of either the bolts or the plates. They also confirmed the view that the point of failure in the rib was at a point well beyond the effect of the rib bolts.<sup>78</sup>

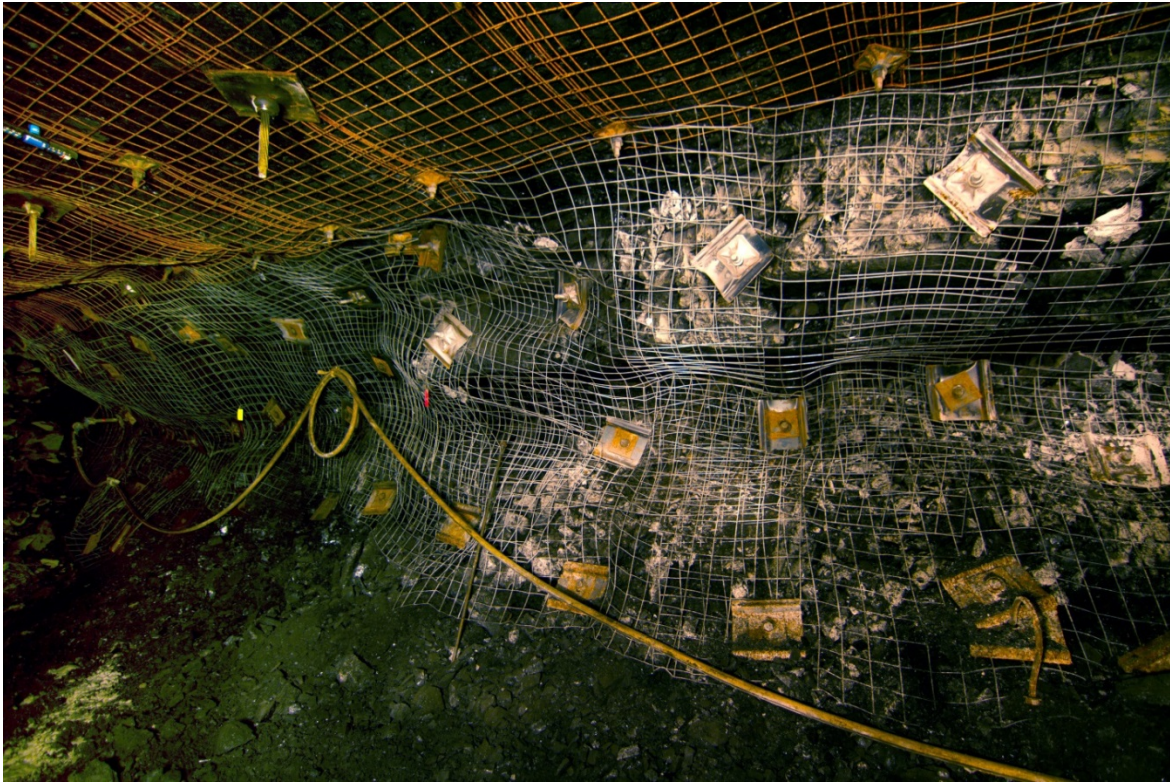
Figure 24 Example of bolting in the adjacent A Heading of MG A9.

Due to the soft broken nature of the ribs at Austar it was common for the operators of the bolting rigs to encounter problems when setting the rib supports. All operators spoken to insisted that if a chemical or mechanical anchor was not properly secured, a new bolt would be installed next to it. This contention is supported by observation of the support outbye of the incident as demonstrated in Figure 24 below.
