Investigation report

Cause and circumstances of fatal injury to
Peter Thomas Jones at Chain Valley Colliery
on 3 June 2011

Extract of report prepared by the
NSW Mine Safety Investigation Unit

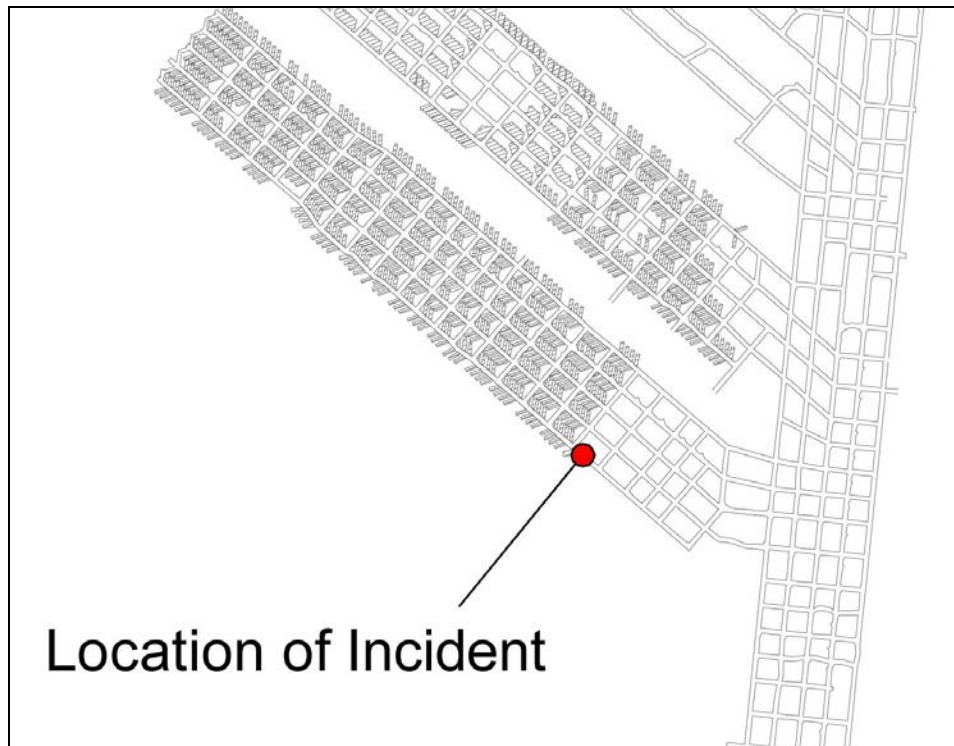
Figure 2 Incident Plan 2 Fassifern seam workings.

In West 6 Panel five sets of roadways were driven from main headings to develop the extraction panel. These roads were connected by mining cut-throughs perpendicular to the main roads – this created large blocks of coal known as pillars. The pillars created in West 6 Panel were typically 24.5m wide x 34.5m long. West 6 Panel developed 23 rows of pillars before partial extraction of the pillars began. West 6 Panel was not overlain by extracted workings in the Great Northern and Wallarah Seams. A cropped Incident Plan 2 Fassifern Seam Workings below shows the board and pillar method.

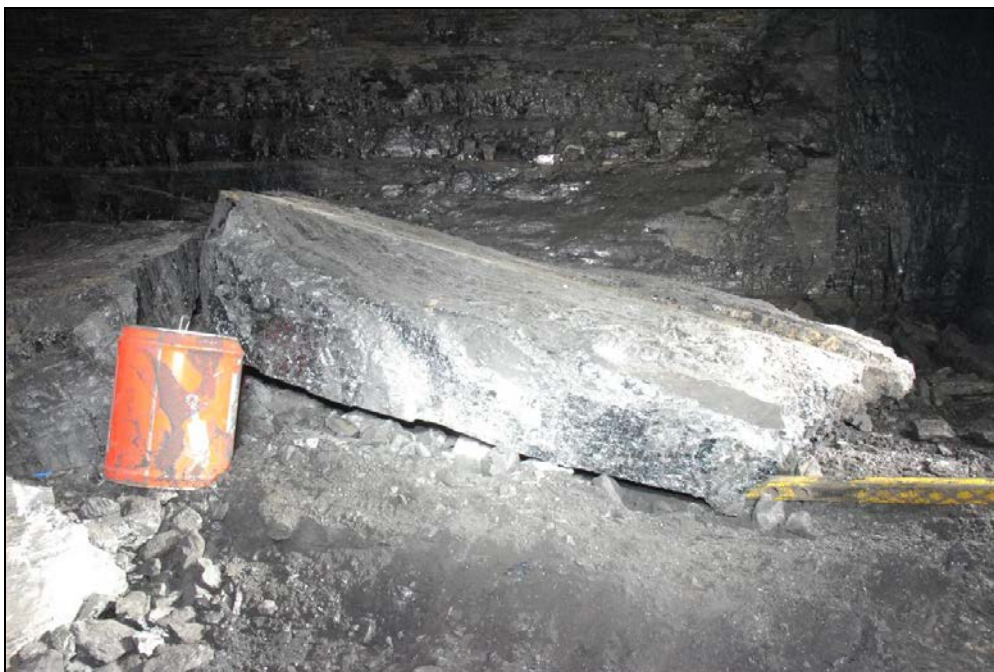
Photograph 10 View of slab showing the red oil drum and steel belt clamp on the right.

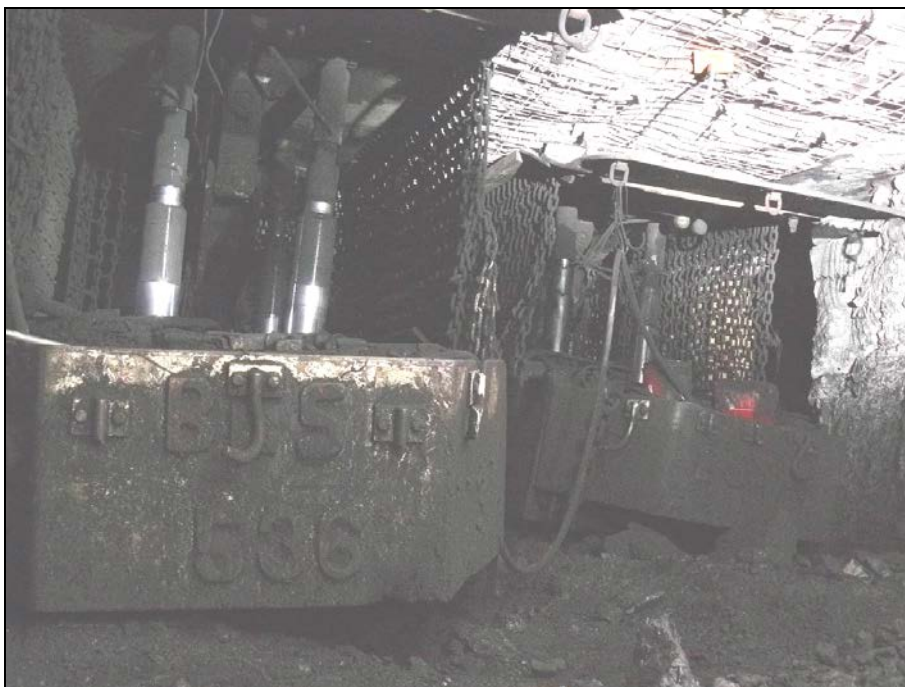
Photograph 14 Looking inbye showing the position of the 2 breaker line supports in B Heading.

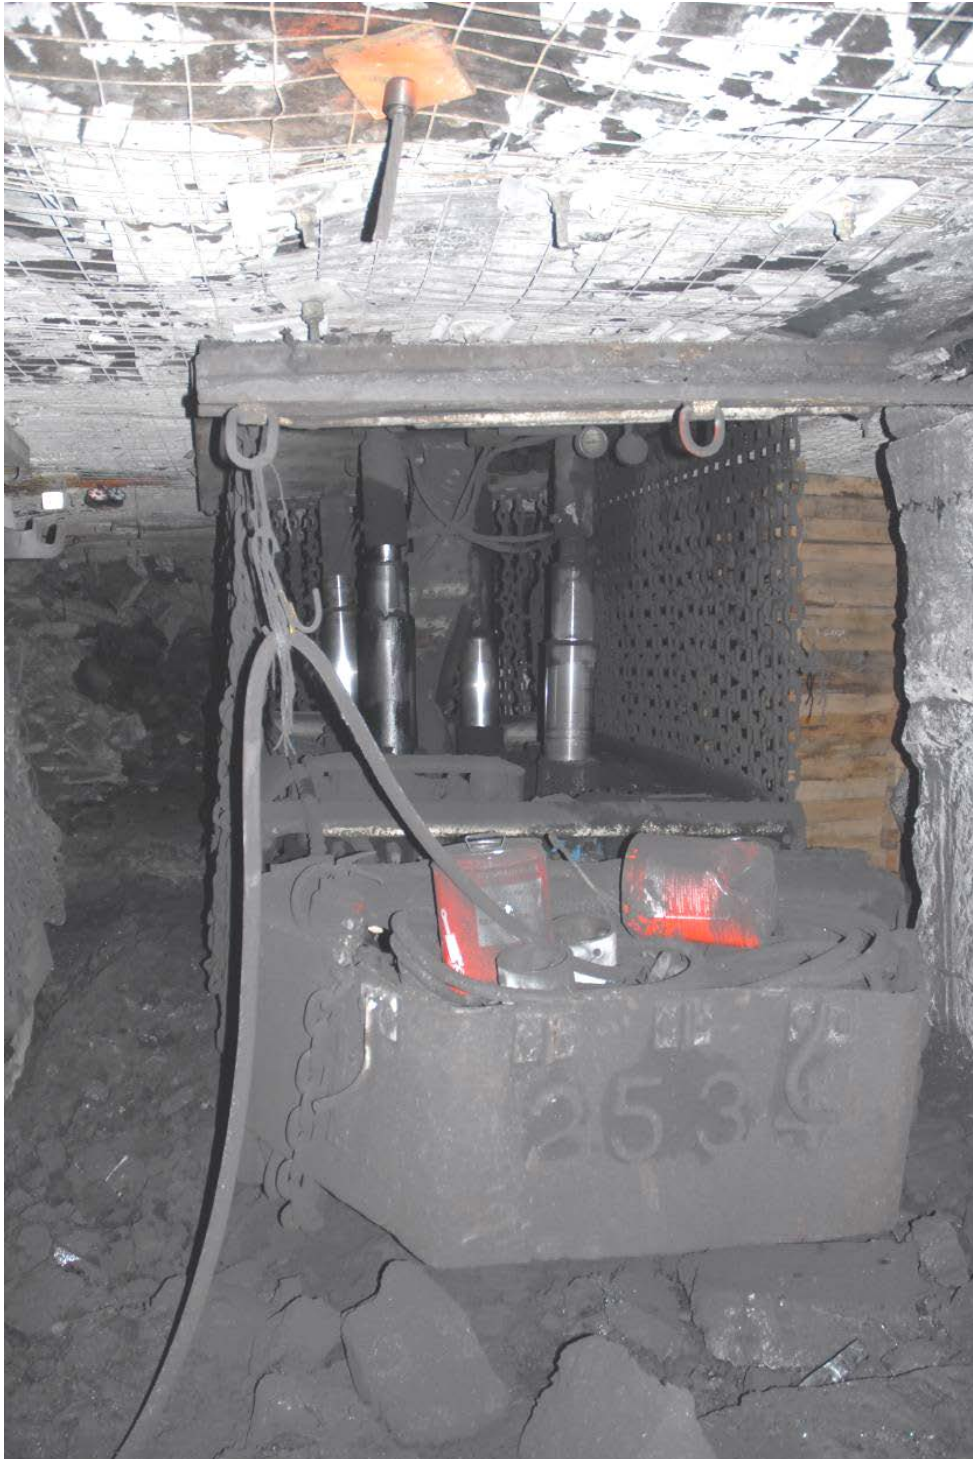
Photograph 15: Visible to the right of the breaker line support is the wooden link n lock chock built at the entrance to 6 cut-through B to C heading. A secondary roof support cable bolt and plate is in front on the breaker line support at the top of the photograph.

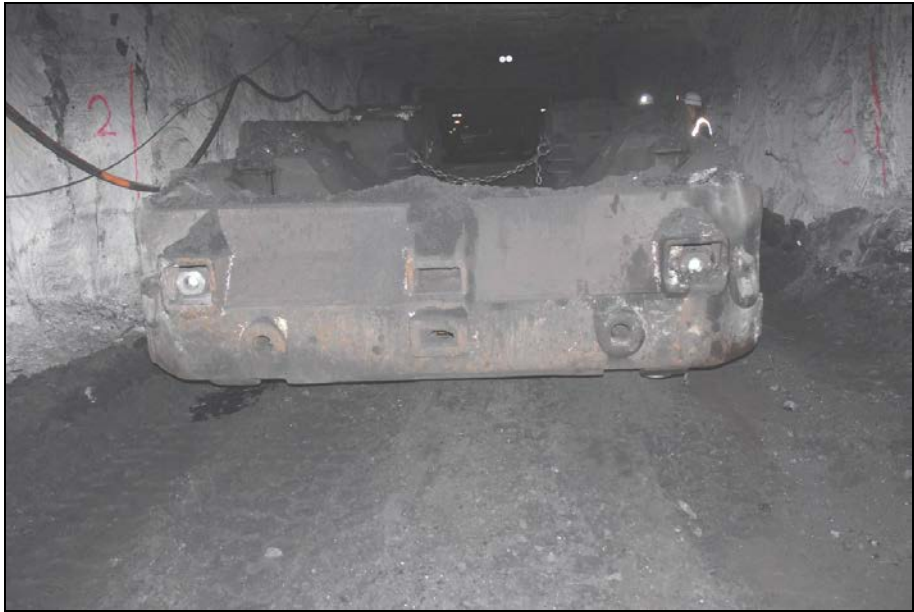
Photograph 20 Looking outbye in B Heading of the right hand shuttle car.

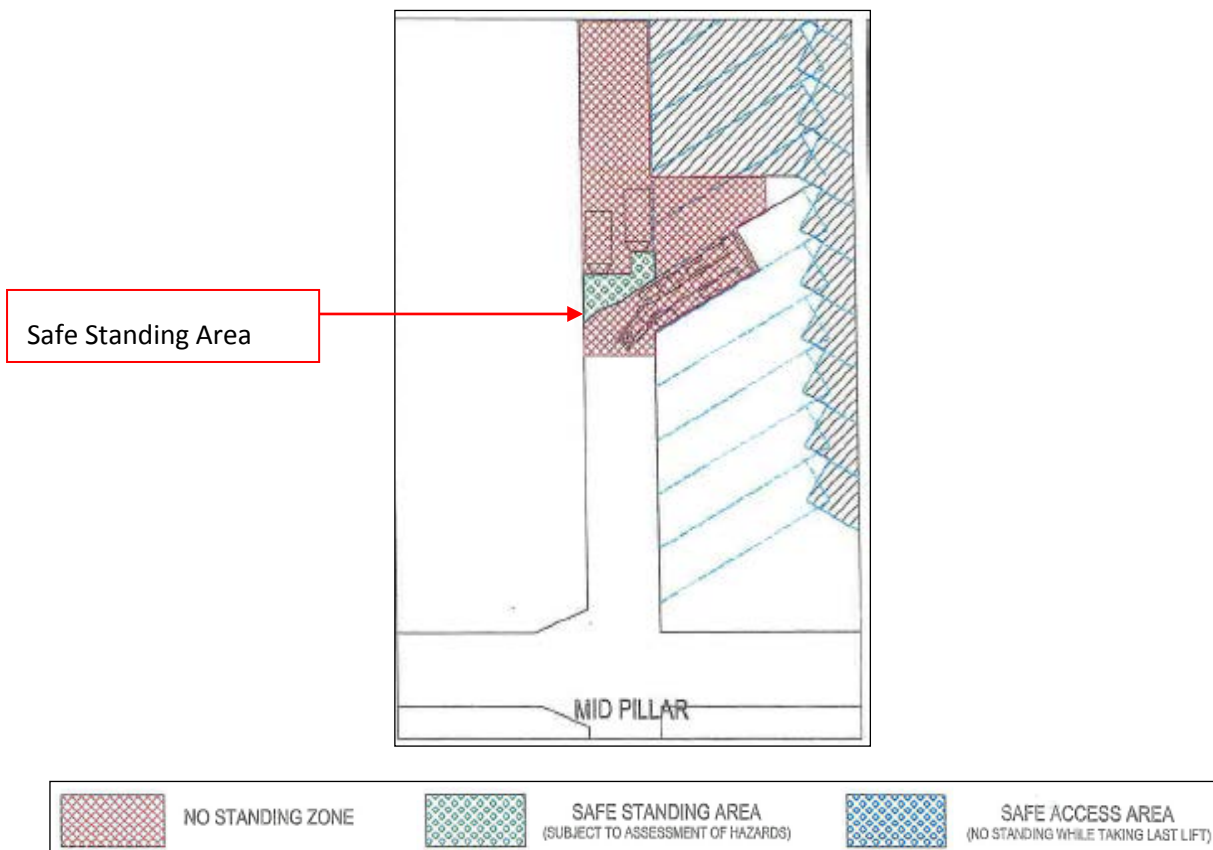
Figure 10 Extract of Fassifern Seam West Panels Safe Standing Areas Single Sided Lifting 11 June 2010

The two documents were shown to mine management by investigators. It was identified that the plans were not specific to the system of work at the time of the incident. However, in review of the available plans, it was indicated that Mr Jones was standing in a “safe standing area” as highlighted in green. That is, it was safe to stand in the position *if all conditions of the managers support rules were sufficiently in place.*
