WEEKLY INCIDENT SUMMARY

Week ending Friday 24 September 2021

INCIDENT TYPE	SUMMARY	COMMENTS TO INDUSTRY
Dangerous incident IncNot0040774 Open cut coal mine

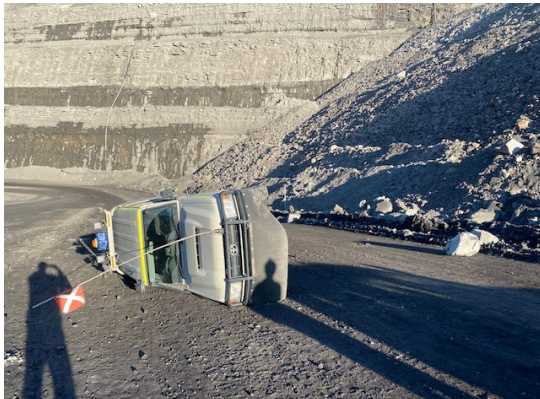
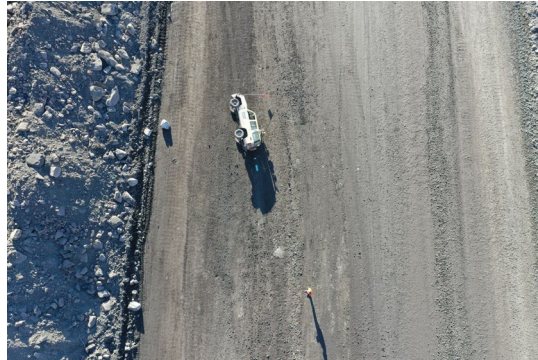
Roads or other vehicle operating areas	<p>A light vehicle overturned when it hit a large rock that was sitting on the haul road. The driver did not see the rock due to the rising sun obscuring his vision. The driver was uninjured and was able to exit the vehicle unaided.</p>

<p>Multiple incidents of this nature have been notified recently and mine operators should communicate this to their workers and reinforce relevant controls.</p> <p>Drivers must maintain focus on the task at hand. When visibility is affected, drivers should find a safe place to stop and address the issue, rather than continuing to drive on. Roadway and intersection designs must consider all environmental factors that could affect visibility, including sunlight.</p>

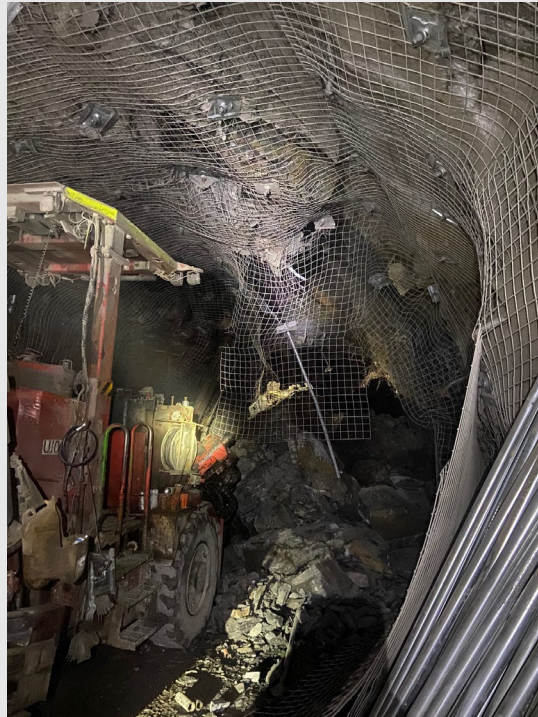
Ground or strata
failure

A jumbo was conducting rehabilitation work for a mine expansion. A fall of ground occurred while fitting the mesh to the roof. The area had not yet been supported. The right-hand boom was buried under rock. The nipper was standing behind the jacks of the machine and the operator was in the cab. Both workers were uninjured.

Operators must maintain vigilance when working near unsupported ground and be conscious of their position. When determining ground support standards, the whole of mine life requirements and potential expansions should be considered.
