WEEKLY INCIDENT SUMMARY

Week ending Friday 23 September 2022

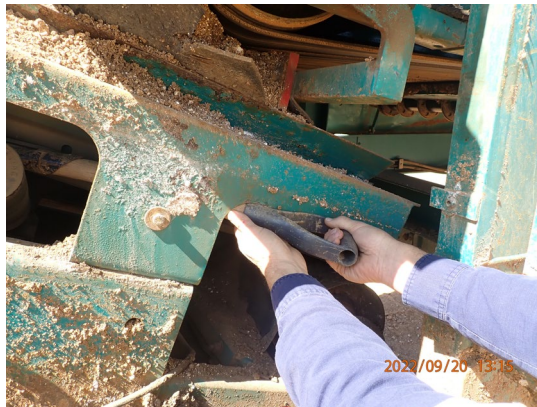
INCIDENT TYPE	SUMMARY	COMMENTS TO INDUSTRY
Dangerous incident IncNot0043057 Industrial minerals mine	<p>A worker suffered severe hand injuries while cleaning a mobile screen. A shovel that a worker was using became caught in a conveyor roller and twisted. This partly removed the tip of one finger and sliced the back of his thumb.</p> <p>The worker was on site for a few weeks and did not have experience of the task he was undertaking.</p> <p>An investigation into this incident was ongoing at the time of publication.</p>	<p>Mine operators must ensure that before any worker starts work at a mine site, the worker is inducted and given information, training and instruction on the safety management system for the mine site.</p> <p>Mine operators should also review the adequacy of their guarding and isolation arrangements to protect workers from the risk of entanglement with operating plant.</p> <p>Isolation and control of all energy sources from plant is essential when adjustments are being undertaken. Engineering controls</p>

should be implemented to allow regular tasks to be conducted without the need to remove control measures (guards).

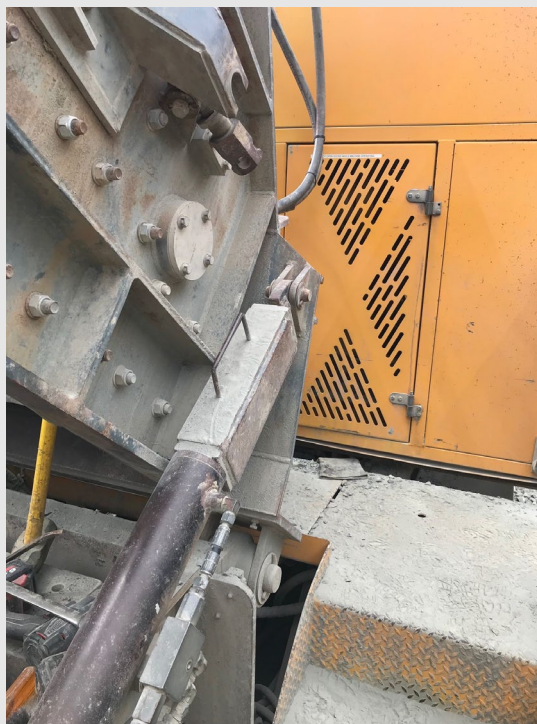
Dangerous incident
IncNot0043075
Construction
materials

A worker suffered crush injuries to 3 middle fingers on a right hand while carrying out maintenance on a mobile crushing plant.

Three workers were changing out blow bars on a horizontal shaft impactor. One of the workers placed his fingers into a pinch point between a blow bar and a lifting tool.

Mine operators and contract companies should review their procedures against the original equipment manufacturers' recommended procedure for this task.

Ensure that documented procedures outline the sequence of tasks to be undertaken.

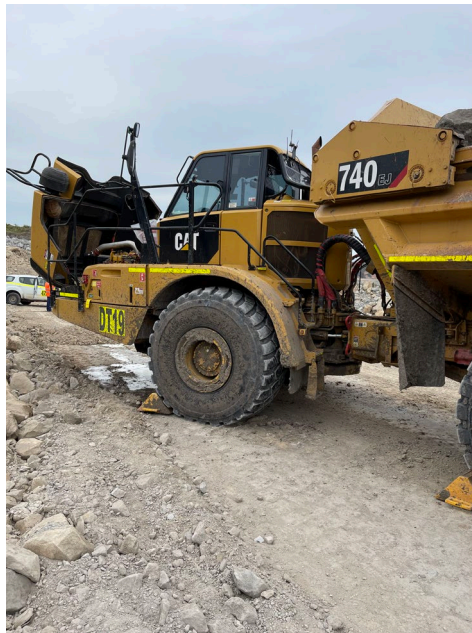
Dangerous incident
IncNot0043082
Open cut coal mine
Roads or other
vehicle operating
areas

A hydraulic hose ruptured and drained the steering oil tank of a truck, resulting in the loss of steering power. The oil sprayed over the engine block and caught fire. The operator initiated the truck's fire suppression, which extinguished the flames.

Hose management and protection is critical in preventing fires on mobile plant. Rubbing hoses are a well-known cause of fires on mobile plant. Mine operators must have systems in place that identify defects and poor hose standards, then assess the situation and put controls in place to prevent fires.

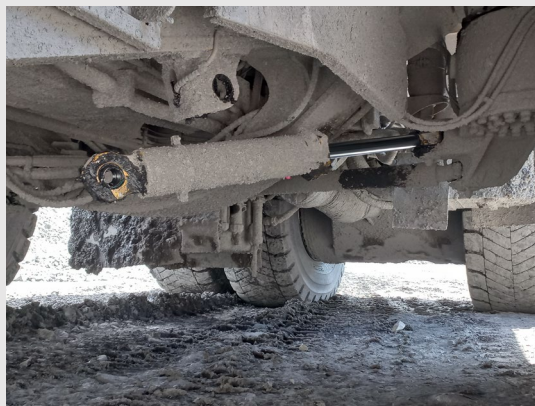
Dangerous incident
IncNot0043096
Open cut coal mine
Roads or other
vehicle operating
areas

A haul truck was travelling down a short ramp from a dig unit when the operator noticed a change in steering function and brought the truck to a stop. Upon investigation, the operator identified the retaining bolt for the steering cylinder clevis pin had become loose, allowing the pin to fall out.

Mine operators are reminded that they must develop and adhere to strict inspection and maintenance standards and practices to ensure plant is fit-for-purpose.

Vehicle operators must carry out pre-start inspections to ensure plant can be operated safely. Safety critical systems such as steering should be inspected, maintained and tested in accordance with the OEM's recommendations.
