Weekly incident summary

Week ending 16 June 2023

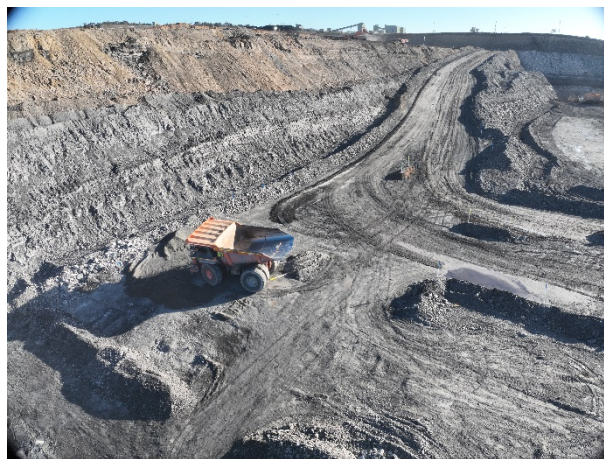
Incident type	Summary	Comments to industry
Dangerous incident IncNot0044878 Open cut coal mine Roads or other vehicle operating areas	A haul truck operator was assigned to a different digger mid-shift. The operator went to travel down a ramp that had not been used since recent wet weather. As the truck was descending the ramp, the rear wheels started to slide. The operator was unable to stop the truck and continued to slide through an intersection. Beyond the intersection was a drill pattern and the operator was concerned this was loaded so steered into the centre bund, stopping the truck.	Mine operators should confirm roads are suitable for use before commencing operations after wet weather. When roads are closed, they should be clearly marked and communicated to workers.

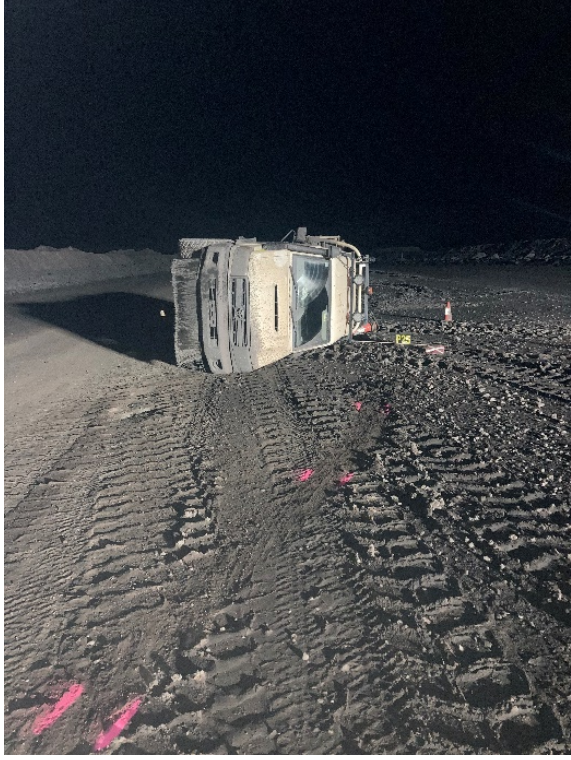
Incident type	Summary	Comments to industry
<p>Dangerous Incident IncNot0044859 Open cut coal mine Roads or other vehicle operating areas</p>	<p>At the end of day shift, 3 workers were driving back to a muster area. The vehicle hit a soft spot in the haul road, causing the vehicle to slide. As the driver tried to correct the slide, the vehicle went from a wet section of the haul road to a dry section. The vehicle rolled. No workers were injured.</p>

<p>When operating plant and equipment workers must remain situationally aware of the environment in which they are operating.</p> <p>Mine operators should assess and demarcate any areas on roads and vehicle operating areas where conditions may pose hazards to vehicle operations.</p>
