# Weekly incident summary

## Week ending 8 December 2023

This incident summary provides information on reportable incidents and safety advice for the NSW mining industry. To report an incident to the NSW Resources Regulator: phone 1300 814 609 24 hours a day, 7 days a week.

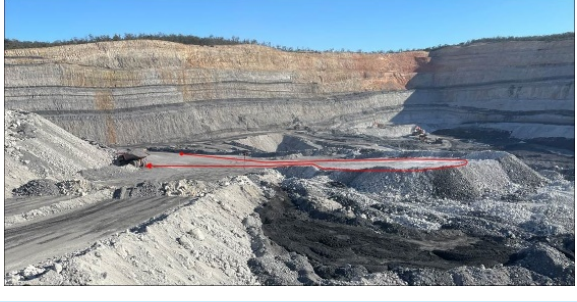
Incident type	Summary	Comments to industry
Dangerous incident IncNot0045948 Open cut coal mine Roads or other vehicle operating areas	<p>The operator of a dump truck turned at the tip head to get into a position to reverse. The operator turned too wide and drove position 1 tyre up onto the windrow at the side of the ramp regrade, exposing the operator and truck to a 3.5 m drop off.</p> <p>The operator continued to drive along the windrow, with position 3 and 4 tyres also mounting the windrow. The operator drove forwards off the windrow back onto the ramp.</p> <p>The operator said they were unable to stop the truck using the brakes, so decided to steer the truck about 90 m across the ramp, on a 9% grade, into the windrow on the edge of the road to stop the truck. The operator was not injured.</p> <p>Initial investigation suggested there was no issue with the braking system.</p>	<p>Mine operators should ensure that all haul truck operators are familiar with emergency braking procedures and that operators are competent in the application of emergency brakes.</p> <p>Truck operators must remain situationally aware when manoeuvring a truck near windrows and dump drop-offs and should use the service brake in emergency situations.</p>

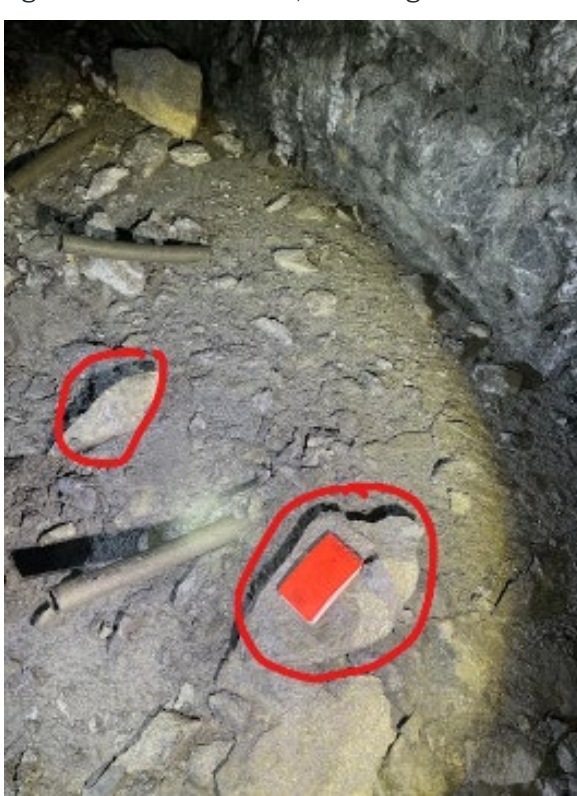
<p data-bbox="113 524 395 562">Dangerous incident</p> <p data-bbox="113 568 395 607">IncNot0045950</p> <p data-bbox="113 613 395 696">Underground metals mine</p> <p data-bbox="113 703 395 786">Ground or strata failure</p>

<p data-bbox="400 524 979 674">While preparing for a shot underground, a piece of rock about 300 mm x 200 mm x 100 mm fell off the face and hit a worker on the right shoulder and back, knocking him over.</p>

<p data-bbox="984 524 1479 831">Mine operators are reminded that when developing the control measures to manage the risks of ground or strata failure, consideration must be given to the geotechnical characteristics of the rocks and issues that can affect stability.</p> <p data-bbox="984 837 1479 1032">Mine operators are reminded that appropriate systems must be in place to ensure that exclusion zone requirements are assessed and are adequate.</p>
