Safety Bulletin

Large number of hand and finger injuries reported

This safety bulletin provides safety advice for the NSW mining industry.

Safety Bulletin SB24-04

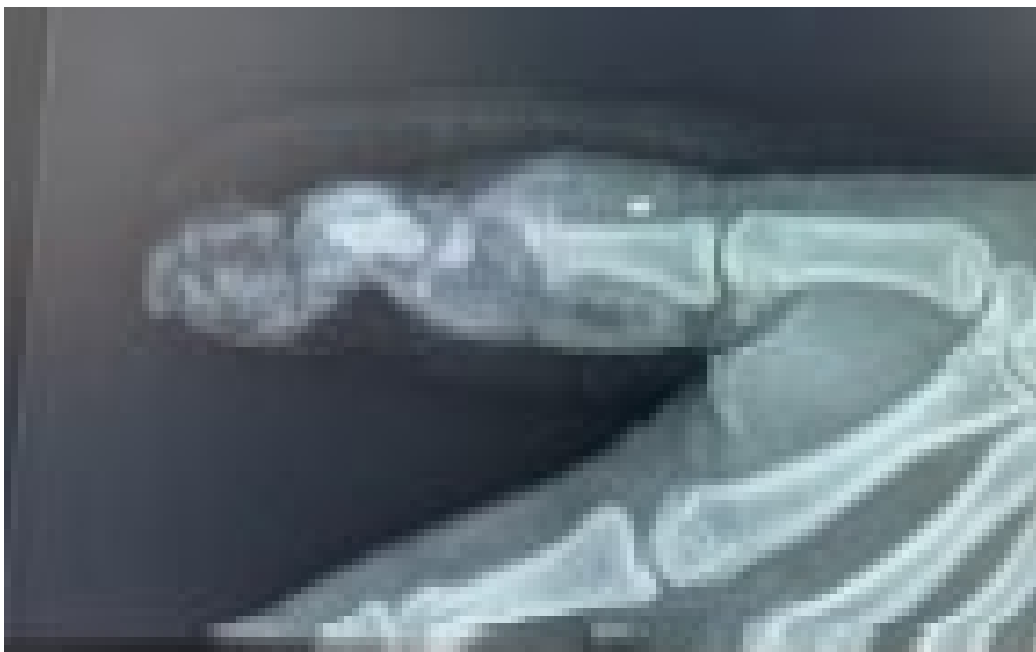
An agitator operator suffered a crush injury to the left thumb, which required surgery. The operator was clearing material into the rear of the bowl when rotating machinery made contact with the operator's thumb.

Figure 1: An X-ray showing the thumb injury

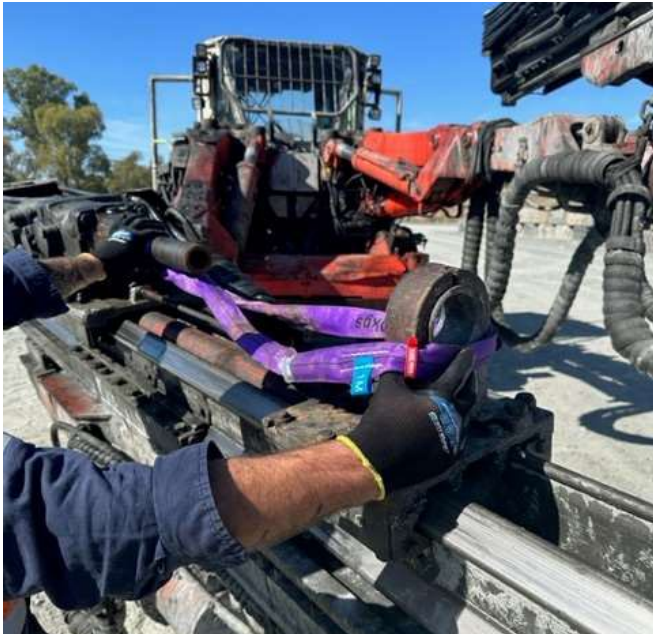
An underground fitter was changing a feed rope on a Sandvik development drill. During the fitting, it was identified that the drifter needed manual adjustment. To make the manual adjustment, a sling was installed onto the drifter at one end. While installing the other end onto a centraliser, the operator operated the lever controlling the boom movement while the fitter's thumb was still under the sling. This degloved the end of the fitter's right hand thumb. The fitter was taken to hospital for treatment.

Figure 2: A simulation of where the fitter's thumb was caught

- When components and parts are being removed, loads must be secured and supported and potential load movement should be considered when identifying hazards.

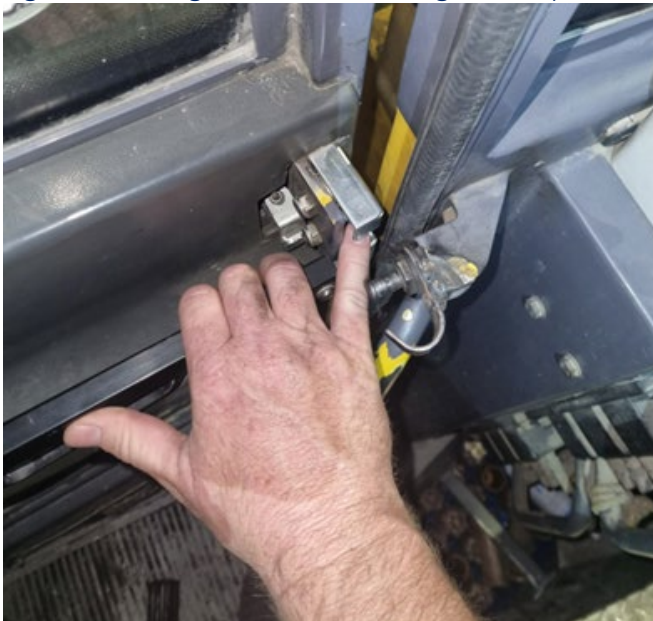
A fitter was entering a Jumbo drill cabin and as he closed the door, the latch did not close properly. The fitter reopened and closed the door with his hand still in the door resulting in a fractured finger.

Figure 3: Showing where the fitter's fingers were placed in the door
