INVESTIGATION INFORMATION RELEASE

Improving rehabilitation, sediment and erosion controls at Castillo Copper exploration project

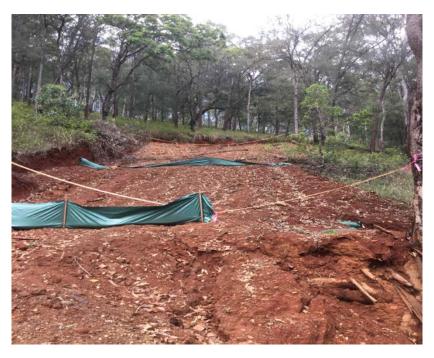
In November 2018 and March 2019, inspectors conducted site inspections at both exploration licences. Inspectors observed waste mounted on topsoil and inadequate erosion and sedimentation controls resulting in tunnel, rill and gully erosion. Inspectors also observed the migration of sediment into the environment, including waterways, which created potential harm to the environment.

Figure 1 below shows inadequate provisioning of sediment and erosion controls resulting in tunnel, rill and gully erosion and associated migration of sediment into the environment, including waterways.

Figure 1 Inadequate sediment and erosion controls

Extensive remedial works have been completed since the licence suspension and the issuing of the statutory notices. This has included installation of erosion and sediment control features, such as:

- low flow drains, swales across access tracks and installation of geofabric
- placing rock piles and sand bags to slow water flow in areas such as long road lengths and low flow drains
- application of vegetation (branches, leaves) across batters, slopes and disused access tracks to slow water flow, control erosion and accumulate resources for rehabilitation (e.g. soil, leaf litter and seeds).

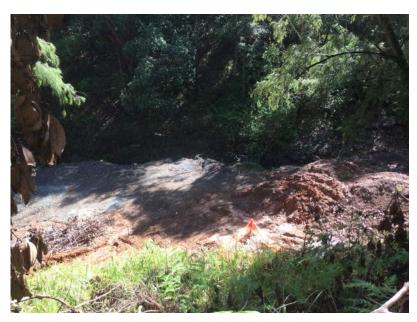
Figures 2, 3 and 4 below show poor management and storage of drill cuttings and associated plastic sample bags with evidence that cuttings have migrated into the environment, including waterways resulting in potential harm to the environment.

Figure 2 Poor drill cutting management and substandard erosion and sediment controls near a watercourse

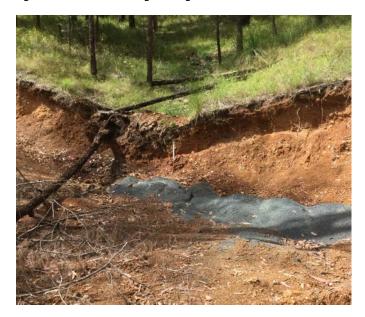
Figure 3 Poor drill cutting management

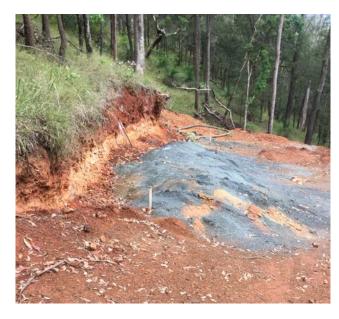
Figure 4 Poor drill cutting management

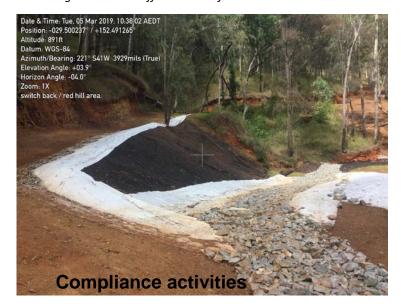
Date & Time: Tue. 05 Mar 2019. 10.47:10 AEDT
Position: -029.500316* / +152.491183°
Altitude: 897ft
Datum: WG5-84
Azimuth/Bearing: 259° S79W 4604mils (True)
Elevation Angle: -07.5°
Horizon Angle: -00.3°
Zoom: 1X
switch back / red hill area.

Figure 5 Effective use of sediment and erosion controls, application of vegetation (branches) across slopes

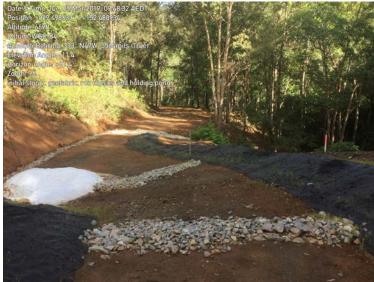
Figures 6 and 7 Effective use of sediment and erosion controls in the form of rock checks and geofabric
