SAFETY ALERT

SECURITY AND SAFETY HIGHLIGHTED IN BOBCAT RIDE AT QUARRY

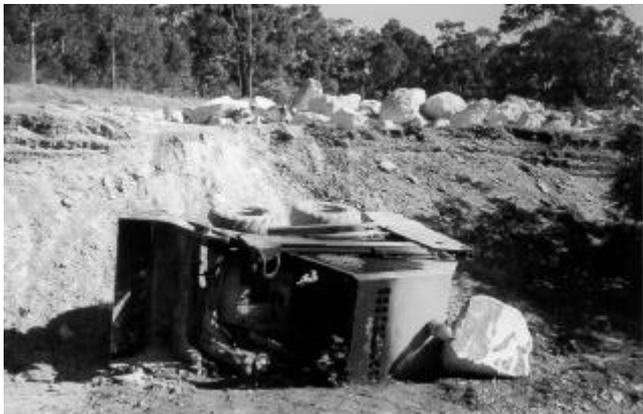
Tyre marks indicated that the Bobcat overturned when going up the slope at an angle. There were no witnesses, and police were called to investigate whether anyone may have reported injuries at a hospital.

From the position of the Bobcat, it is very possible that the driver might have serious injuries.

The photo shows the Bobcat lying on its side at the bottom of the slope. The large stone next to it may have rolled down the slope and contributed to the accident.

This incident highlights the need for adequate site security at all mines and quarries.

- Security fences should be complete, without gaps.
- Keys should NOT be left in parked mobile equipment.
- Additional controls, including patrols, alarms and vehicle immobilisation might be considered.
