SAFETY ALERT

DRILL RIG NEAR MISS

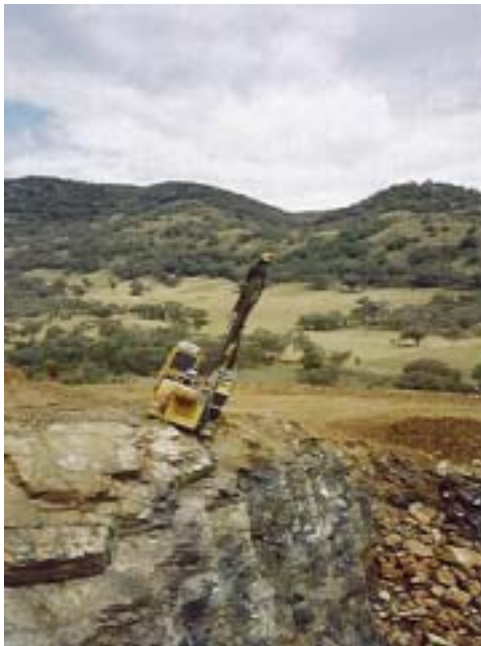
A drill rig came very close to the edge of a 12-15 metre high quarry face. The driller was very lucky that the drill rig did not fall over the edge. He was not hurt.

When the driller reversed to get ready to drill the next hole, the rig lost grip and slipped. The driller tried to get the drill rig back into place, but it slewed around and slipped even closer to the edge of the quarry.

The photo at left shows how close the drill rig came to the edge of the quarry face.

- The design of the quarry meant that there was not enough room for the driller to put the rig at right angles to the quarry face.
- The driller could only get to the drilling spot from one direction.
- The driller did not know how close to the edge of the quarry he was.
- There were no markers (or bunding) in place to show where the quarry face started.

- Mines to review the hazards, procedures and controls associated with bench drilling.
- Controls should include:
 - ♦ Blast plans which reduce restrictions to access and work areas.
 - ♦ A formal assessment process to identify hazards and to put controls in place before drilling starts.
 - ♦ Bunding of high walls as a routine part of safe work practices.
 - ♦ The use of documented procedures to manage high-risk activities.
