WEEKLY INCIDENT SUMMARY

Week ending Friday 11 September 2020

INCIDENT TYPE	SUMMARY	COMMENTS TO INDUSTRY
Dangerous incident IncNot0038226 Underground coal mine

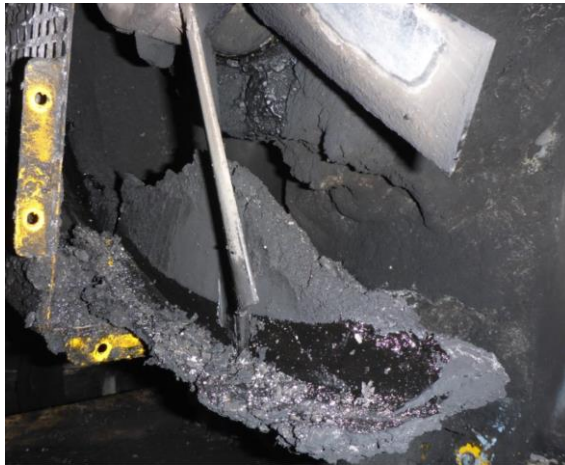
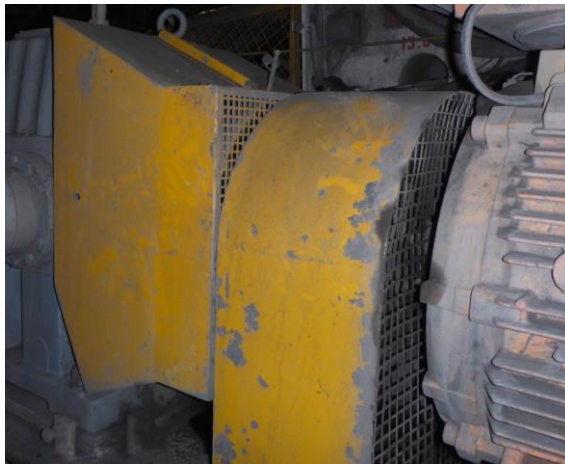
Fire or explosion	<p>Workers in an underground coal mine smelt something burning and noticed that the gearbox output shaft of a conveyor belt felt warm. They saw small embers in a build-up of material behind the coupling cover.</p> <p>An initial investigation indicates that the overloading of the gearbox may have occurred, resulting in oil overheating.</p>	<p>Mines should ensure that temperature monitoring is installed in locations where it is most likely to detect and alert an increase in temperature from component wear/failure or low oil levels.</p> <p>Conveyors should not be operated outside of original equipment manufacturers operating parameters such as load, temperature and oil specifications.</p>

Areas where material can accumulate, such as under guards, should include methods to allow for inspection and cleaning. These areas should be included in routine maintenance inspections.
