WEEKLY INCIDENT SUMMARY

Week ending Friday 22 January 2021

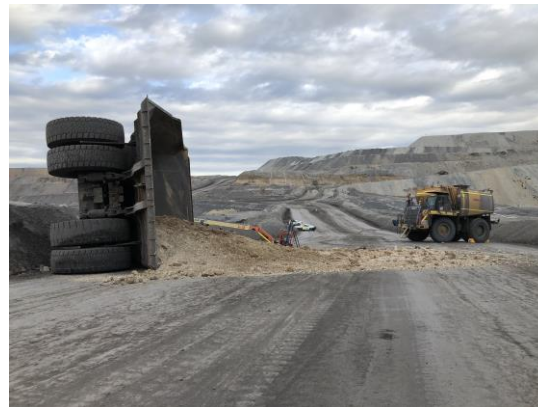
Dangerous incident
IncNot0039070
Open cut coal mine

An operator driving a fully loaded dump truck was descending a ramp when the truck has veered into a windrow and rolled onto its side.

Mine operators should reinforce the application of procedures, including fatigue management, use of mobile phones and compliance with speed signs.

Equipment operators must maintain situational awareness and remain vigilant of the risk of machine rollovers. This incident underpins the importance of wearing seatbelts as a mitigating control. When planning tasks and travel paths, supervisors must consider rollover hazards. [Refer to Safety Bulletin: SB17-01 Industry reports more truck rollover incidents](#)

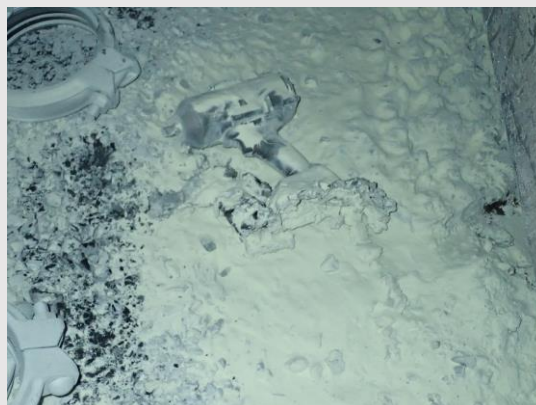
Dangerous incident
IncNot0039071
Underground coal mine

A fire has occurred underground when an LHD has run over a battery-powered drill. The drill fell on the roadway after it was left on some poly pipe.

Mine operators should review their safety management system to ensure the risks associated with the use of battery powered portable electrical apparatus have been addressed. Risk assessments should consider:

- manufacturers safety information
- suitability of battery charging equipment and location
- transport and storage of batteries
- suitability of the equipment for the environment
- control of batteries in underground parts of the mine and hazardous areas including permit systems,

operator competency, chain of custody and transport and storage conditions.

- inspection regimes and regimes for removing batteries from service and lost or damaged equipment.
