WEEKLY INCIDENT SUMMARY

Week ending Friday 24 July 2020

This incident summary provides information on reportable incidents and safety advice for the NSW mining industry. To report an incident to the NSW Resources Regulator: phone 1300 814 609 24 hours a day, 7 days a week.

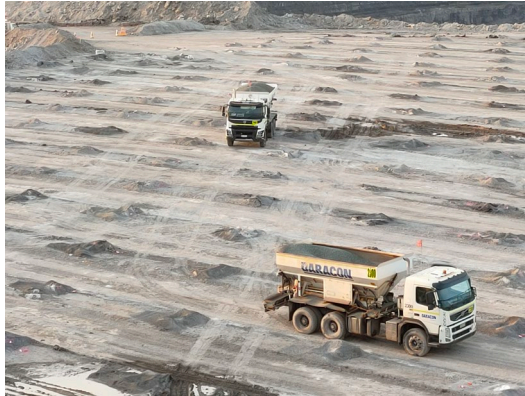
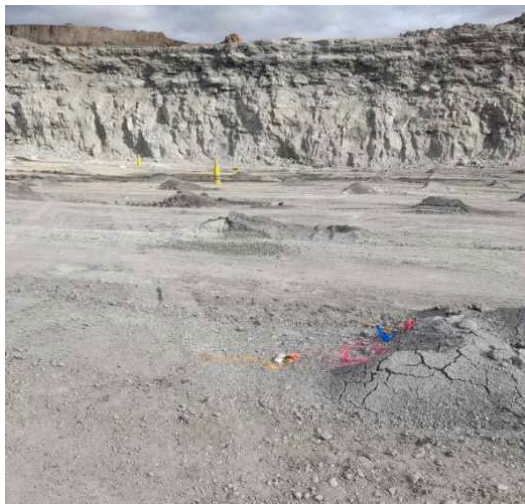
INCIDENT TYPE	SUMMARY	COMMENTS TO INDUSTRY
Dangerous incident IncNot0037797 Open cut coal

<p>A stemming truck ran over a detonator and booster during the loading of shot holes. The shotfirer in charge removed one level of IE/HE from the holes and placed them adjacent to the holes on the next path.</p> <p>After travelling the same path on five occasions that morning, the stemming truck operator has turned down the adjacent path.</p> <p>The operator did not see the detonator and booster on the ground and drove over it. No ignition of the explosives occurred.</p>	<p>The traffic management plan for the shot floor should clearly identify travel routes so that trucks do not inadvertently drive along the incorrect path.</p> <p>Drivers should know the travel routes before entering the shot floor. To aid the drivers, demarcation of usable tracks should be clearly identified by using visible cues such as cones or signage.</p> <p>Mines should ensure effective supervision and auditing of compliance with documented traffic management plans.</p>

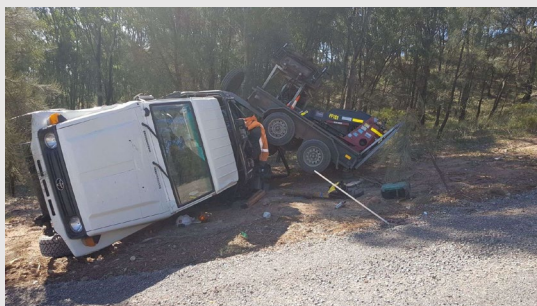
Dangerous
incident
IncNot0037817
Open cut coal

A light vehicle towing a trailer loaded with a dingo, ran out of power while pulling the trailer up a steep section of road. The trailer and vehicle rolled backwards down the road and both overturned one and a half times.

The driver was uninjured.

It appears the vehicle hubs were not engaged, and the operator was towing in 2-wheel high range.

Mines should ensure that vehicles and trailers are fit-for-purpose when being used to transport a load. The suitability of the towing vehicle to handle the trailer mass and the trailer load should be assessed.

Mines should check that their 'introduction to site' process is being properly applied and ensure that vehicle operators are competent to use the vehicle for towing purposes.
